Quality Engineering Design and Construction in Malaysia: A Fast Disappearing and Endangered Commodity?

by Ir. Assoc. Prof. Dr
Jeffrey CL. Chiang

WHAT IS IN THE INVESTIGATION REPORT ON THE ROOF COLLAPSE OF THE KUALA TERENGGANU SPORTS STADIUM?

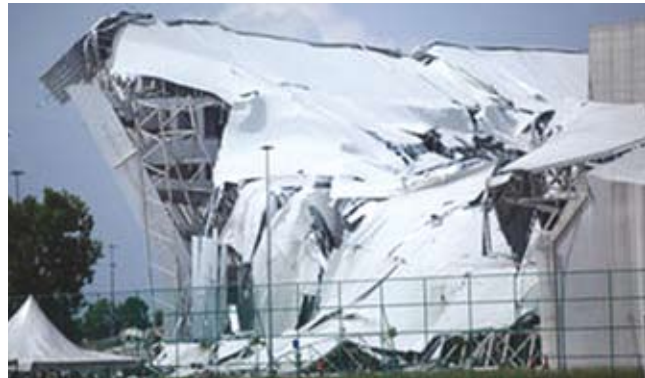
Figure 9: The damaged portion of the stadium - (Courtesy of NORDIN A. RASIP)

- The design was inadequate; the designer failed to take into account the full consideration of the support conditions of the roof structure;
- The roof was erected poorly resulting in misaligned geometry;
- There was no quality control at site; and
- Materials and quality of workmanship did not meet specifications.

- The complexity and long spans of the roof structure require a more detailed design consideration into second order design analysis, which was not carried out.
- The sensitivity of the space frame roof structure requires consideration for support flexibility in the design mode, which was not done.

- Defective welding in steel components, reflecting the poor quality of manufacturing or pre-fabrication work.
- Poorly conceived erection method in installing the roof structural components, and no checks were conducted during the interim stages in erection.
- Inadequate temporary supports used.
- No apparent quality control by the project management team.
- Alternative design proposals provided by main contractor were adopted without integrated checks.
- Preliminary testing of materials used show strengths below design requirements, not meeting specifications.

The above two factors have contributed largely to the collapse by causing a reduction in the safety factor of the structure – which was well below the norms required of such designs.

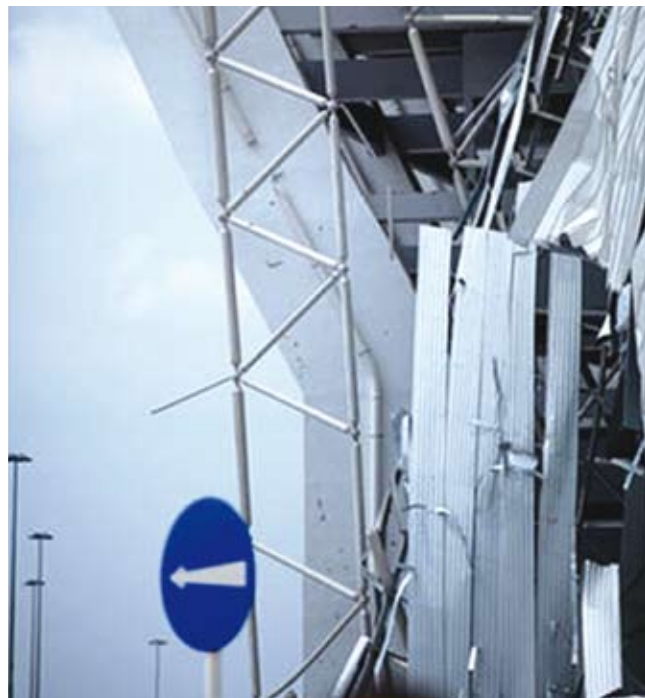
Figure 10: Part of the caved-in structure - (Courtesy of NORDIN A. RASIP)
