Case Study: Successful Filter Installation

by Mr. Jonn Pua and Engr. Andrew Teh, Power Quality Engineering Sdn. Bhd.

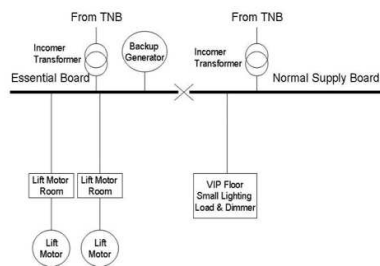
Initially, the VIP floor power supply was connected to a normal supply board which did not have backup supply during utility blackout. Upon request, the in-house engineers moved the VIP lift floor supply from a normal supply board to an Essential Board. (Figure 1)

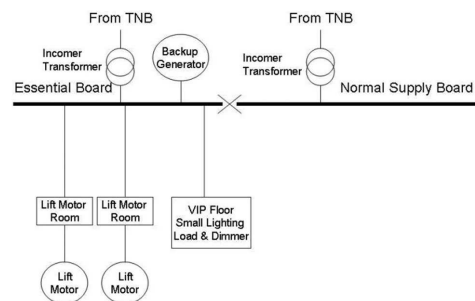
From the PQ survey, PQE found that large loads, such as the building lift banks operated by DC drives, produces high harmonic distortion. The lift operation causes a rapid change in current within a short period which led to high voltage flicker. Thus, the Essential Boards power supply was not clean and this resulted in the power quality problems.

The recorded input RMS voltage trending suggests that the 415V incoming supply fluctuates rapidly. This high dv/dt, causes an additional voltage stress to the connected load. This leads to a premature failure of the loads, which consists of the air-conditioning system, inter-communication system, lighting dimmer system and suction fan.

P Q E subsequently installed a PQ7 Voltage Source Filter to the Essential Board. This resulted in a more reliable performance with zero failure to the connected load.

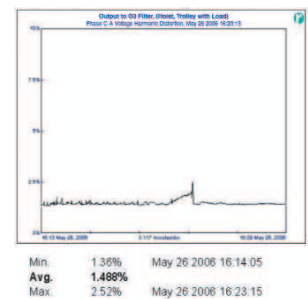
Acceleration and Deceleration with Load
Recorded Total Harmonic Voltage
Distortion Trending
at Output of PQ7 Voltage Source Filter

The above graphics show the recorded total harmonic voltage distortion (THVD) trending at input and output of the PQ7 Voltage Source Filter.

The recorded high input total harmonic voltage distortion suggested that the 415V incoming supply experienced a THVD higher than the maximum allowable limit of 5% as stipulated in the IEEE 519 Engineering Recommendation. On-site power measurement data shows that, with the installation of PQ7 Voltage Source Filter, there was improvement in RMS voltage dv/dt, harmonic voltage distortion and voltage flicker short-term severity index.

The recorded data also confirmed that the installed PQ7 Voltage Source Filter has helped the 415V feeder meet IEEE 519 (engineering recommendation for harmonic distortion) and ER P28 (engineering recommendation for voltage flicker severity index) requirements.
