# Can Lessons be Learned from a Displaced Single Storey Staff Quarters Building Allegedly Due to Adjacent U-drain Construction?

By: *Engr. Tan See Teik, M.I.E.M., P.Eng.*

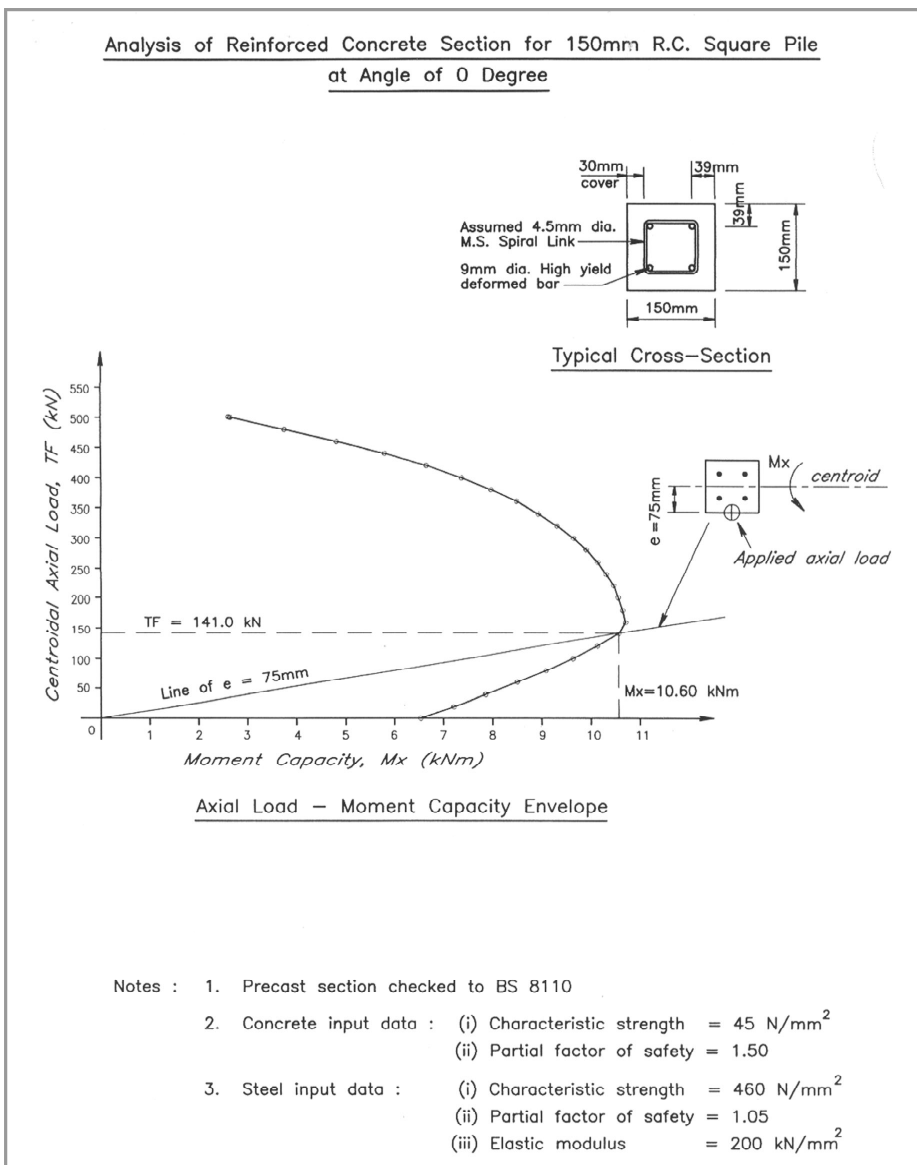
Figure 1

The axial load-moment capacity envelopes as determined by the author of the 150mm x 150mm reinforced concrete pile with Grade 45 concrete and 4 nos. 9mm diameter high yield deformed bars are presented in Figures 1 & 2.

103mm in the diagonal direction of the 150mmx150mm r.c. pile. With the said (large) offset the design ultimate axial load of the pile would be only 80 kN. If this diagonal offset were limited to 75mm the corresponding design ultimate axial load of the pile would be 122 kN.

Where the piling offset is 75mm in the direction parallel to any pile face, the design ultimate axial load of the pile would be 141 kN.

**Analysis of Reinforced Concrete Section for 150mm R.C. Square Pile at Angle of 45 Degree**
