Failure Investigation of the Flashover of an 11 Kv Oil Link Unit

By: *Engr. Iszuan Shah Syed Ismail, Engr. Mohd Raffi bin Samsudin, Ng Guat Peng, Engr. Qua Hock Chye, Engr. Mohd. Noor Harun and Ismail Shariff, MIEM, P.Eng.*

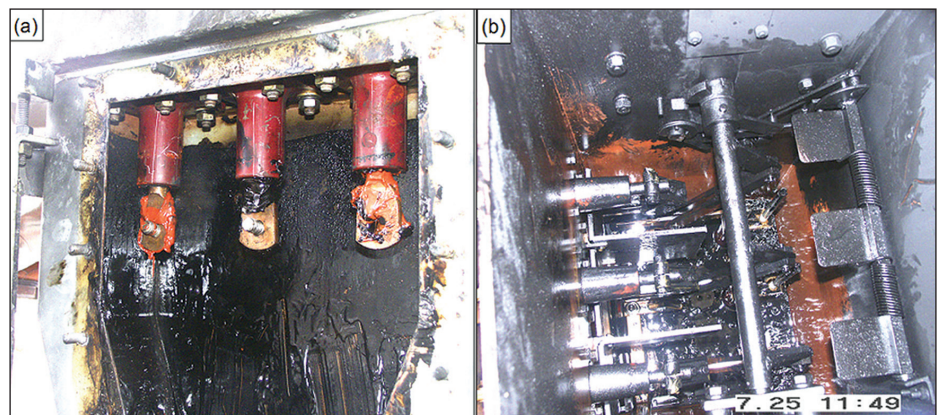
Figure 1: Switching and incoming cable compartment

The Failure Analysis Group, together with the Asset Manager, Asset Maintenance unit and the manufacturer, went to the site for further investigation of the damaged OLU. All of the parts on the damaged OLU were intact after the incident. However, the switching and incoming cable compartment was filled with black soot as in Figure 1.

The oil level was approximately 2 inches lower than the minimum required level. The low oil level was most probably the result of splashing of oil from the switching compartment during the flashover. The damaged drain cap had contributed very little to the low oil level. However, scheduled maintenance conducted three months prior to the incident did not detect any oil leak. The leak, if any, could have been very minimal.

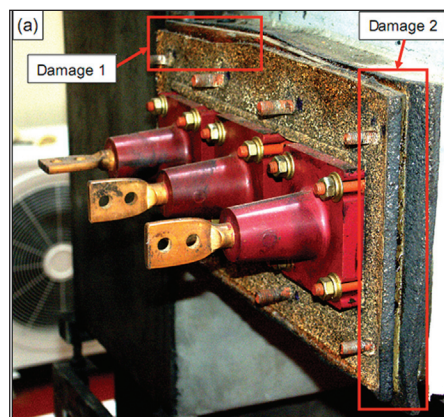
Figure 2: Busbar connection plate

However, the gasket on the busbar connection plate was observed to have deteriorated (Figure 2).

- The condition of the gasket and rubber seal of the OLU should be changed when its condition have deteriorated.
- An oil analysis should be carried out whenever there is a change in colour or when the oil volume had gone below the minimum required level.
- All new OLU's to be purchased should have sight glass to show the level of oil in the switching and busbar compartments.
- The person who handles switching must always wear PPE to avoid any injury.
