External Patch Fillet Repair for Sulphur Recovery Unit of Petroleum Refinery Plant

In this project, the method of repairing the SRU wall due to thinning is presented. Routine inspection detected irregularities on the part of the SRU reheater external shell wall. In order to avoid future unplanned operation disruption, the repair was performed according to codes and standards.

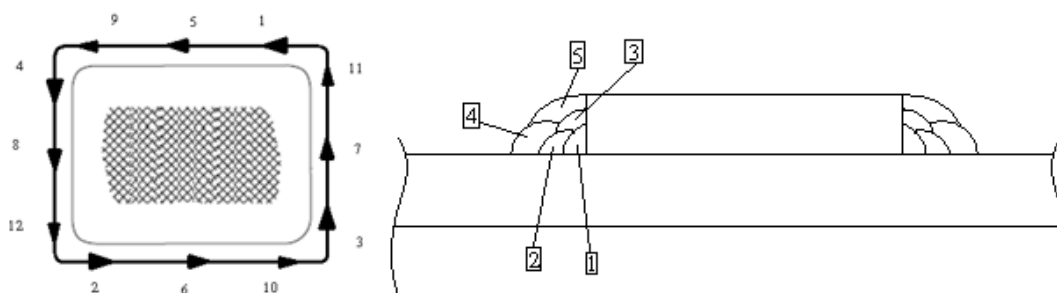
The patch plate was then fitted up onto the shell wall and it was observed for any separation between plate and shell. The measured maximum separation distance is 5 mm which is acceptable by the standard. Once this critical criterion is satisfied, the plate is then welded on the shell using the welding sequence as shown in Figure 7 to minimize plate distortion. To avoid gas pressure build-up between the patch plate and the pressure component boundary, provisions for venting during the final closure weld or post-weld heat treatment is necessary.

Figure 7. Welding sequence.

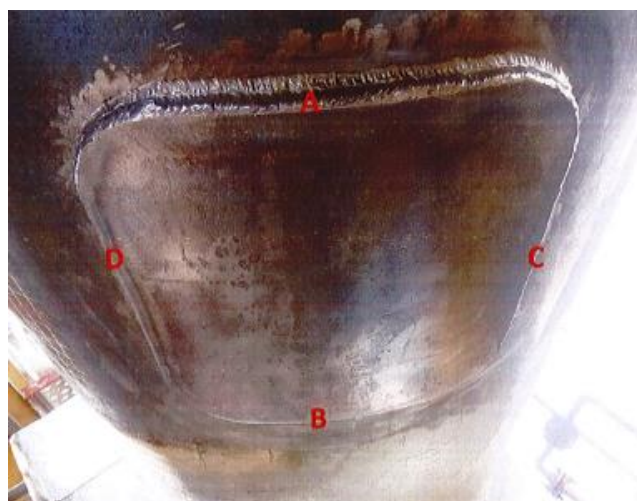
Magnetic Particle Testing (MPT) (root and capping) and hardness testing shall be performed after welding completed by a certified welding inspector to ensure free from any defect (max hardness value for carbon steel 225 HBW). Figure 8 depicts the location of the hardness point. For the final acceptance, the hydro test was performed at the shell side. Shell side test pressure was set at 5.4 kg/cm². The baseline thickness of the patch plate was measured using UT grid scanning. Finally, the patched area was cleaned and painted as per the Petronas Technical Standard (PTS) 15.20.03 was applied (coating system M-9-3).

Figure 8. Location for Hardness Test after Fillet Weld.
