## CHAPTER 4

### RESULT AND DISCUSSION

#### 4.1 Troubleshooting The Hardware and Software .

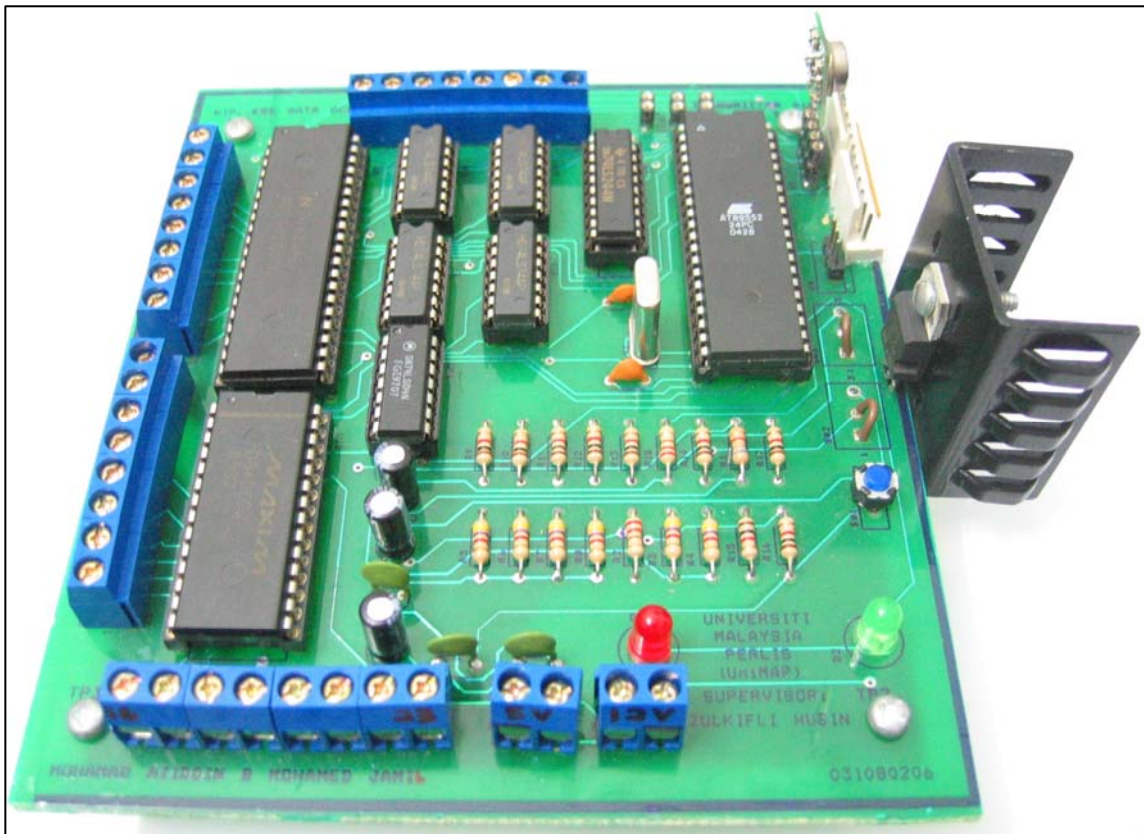
**Figure 4.1:** Transmitter Board

Figure 4.1, Figure 4.2 and Figure 4.3 are the result of the PCB fabrication. Before the overall system is functioning, the transmitter and receiver circuit are malfunction and need to be troubleshoot. An analysis is done on all circuits by examine the circuits diagram and its layout respectively. The first error detected is the IC LM7805 structure. This device acts as a voltage regulator which convert any voltage value supplied to the device and produce a constant 5V output voltage The typical pin configuration is the Voltage In (Vin) at pin 1 , Ground (GND) at pin 2 and Voltage Out (Vout) at pin 3. Unfortunately, the device is mistakenly selected which is the different type during the schematic drawing at Capture CIS. Its Vout is at pin 2 and GND is at pin 3. The solution is by drilling a new hole at the nearest device at the PCB and external wiring is done. This error has made an IC AT89S52 burned due to over voltage load.

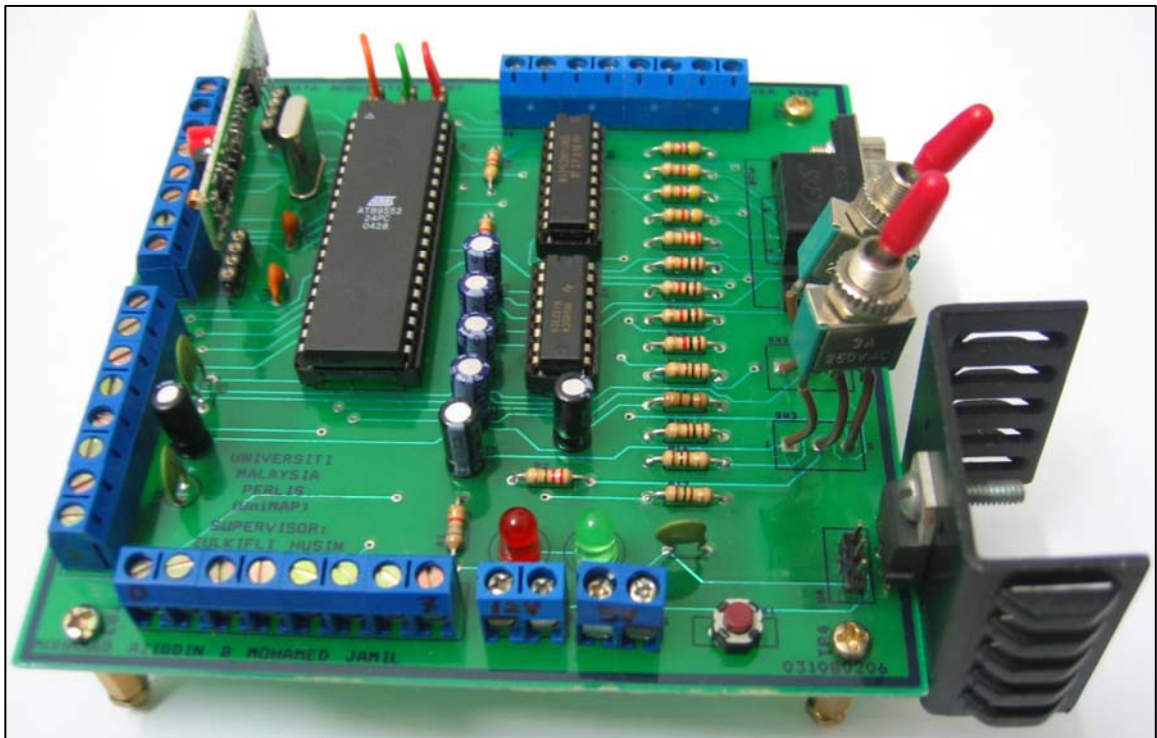
**Figure 4.2:** Receiver Board

Based on Figure 4.2, it is shown that the receiver board is the only board that is capable to perform the SPI-Flash programming. But, as a program file in HEX format is attempted to be executed, the software informed that it is unable to respond with the microcontroller. Thus, the board is being troubleshoot again but this time it focus on the loader circuit.

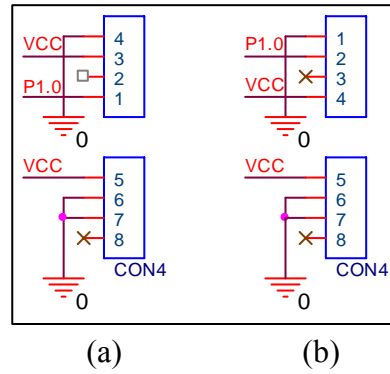
**Figure 4.5:** (a)The Error Position (b)The Desired Position

The second error that is detected is the DB9 connector at the receiver circuit. This device is used as the connector for the ISP program loader and the serial RS232 communication. The error is that the connector is placed facing inside the circuit where it actually must be facing outside the board. Therefore, to overcome this error, another drill is done at the correct position and the pin is reconfigured to be compatible with the exact configuration. The next error encountered is the RF module RLP434A's placement on the circuit which the pin 1 until pin 4 is arrange in reverse sequence. This had made the wireless communication is disable for data transmission. Thus, the mistaken routes are being cut and the new routes are created by using wire wrap in order to rearrange the sequence back in order.

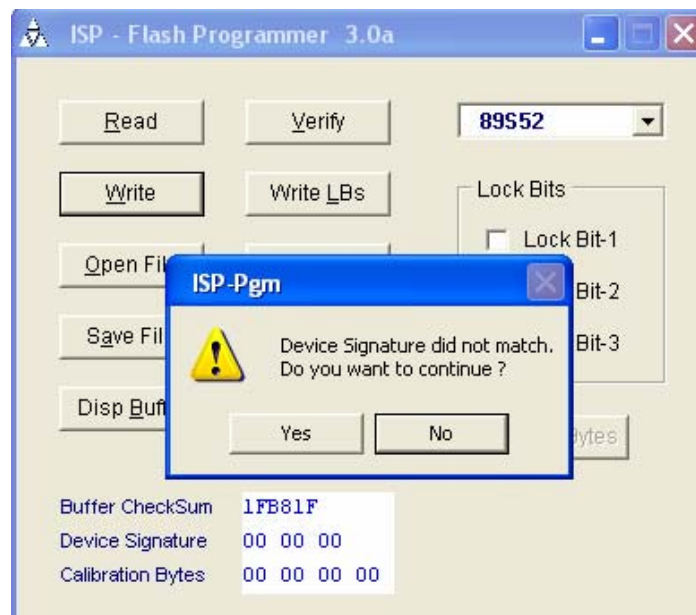
**Figure 4.6:** Error During First Download Program

After a long period of troubleshooting, the problem is solved which the error is the resistance values for the resistors between pin selectors of pin 1.5, 1.6 and 1.7 from the microcontroller. The resistors being soldered on the board are  $1k\Omega$  while the values must be around  $100\Omega$ . Therefore, the solution is to discard the soldered resistors and install the new  $100\Omega$  resistors at the respective place. As a result, the board is capable of performing as an SPI-Flash programmer. This can be verify by clicking verify or signature on the software downloader panel.
