EVALUATION OF RUTTING POTENTIAL OF HOT-MIX ASPHALT IN VARIABLE CONDITIONS

Keywords: Hot-Mix Asphalt, Rutting, ACW14 and ACW20

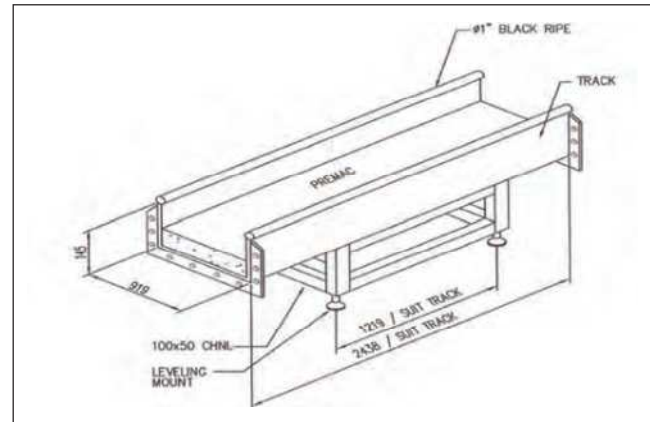
Figure 1: Isometric view of the wheel track

To determine the rutting potential of HMA in variable conditions, calibration of the wheel track must be carried out first before any experimental work can start. The wheel track used in this study had a width of 919 mm and a total length of 22.6 m (Figures 1 and 2). Calibration work was performed to determine the speed for each dial number with variable imposed load. The imposed load implied varies from 80 kg (self-weight of the wheel) to 180 kg. From this calibration process, an appropriate speed was adopted to obtain the rutting potential of HMA in variable conditions.

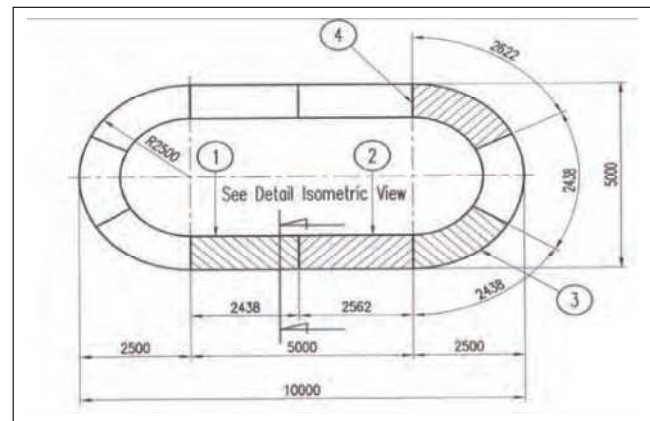
Figure 2: Plan view of the wheel track

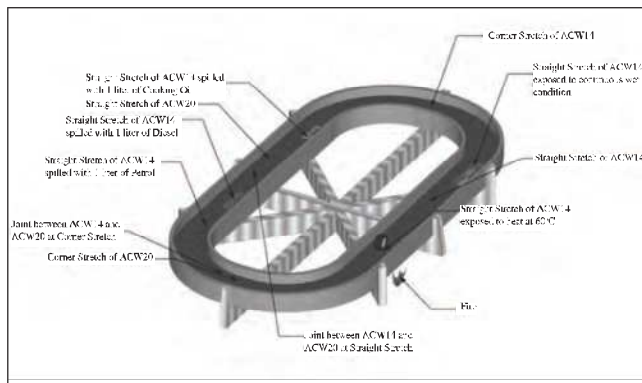
Figure 3: Different regions exposed to various environmental conditions

To obtain rut equations for variable environmental exposure, the track was then sub-divided into the following regions: straight and corner stretches of ACW14; straight and corner stretches of ACW20; joint between ACW14 and ACW20 at straight and corner stretches; a straight stretch of ACW14 exposed to a temperature of 60°C; a straight stretch of ACW14 exposed to continuous wet conditions; a straight stretch of ACW14 with a spillage of one liter of petrol; a straight stretch of ACW14 with a spillage of one liter of diesel; and a straight stretch of ACW14 with a spillage of one liter of cooking oil. For each test, a section of rut was measured every 50 cycles of the wheel track, which weighed 280 kg. A total of 400 passes were made to obtain the desired results. These regions are shown in Figure 3. This study also concerned about the effect of environmental exposure to rutting performance on pavement.

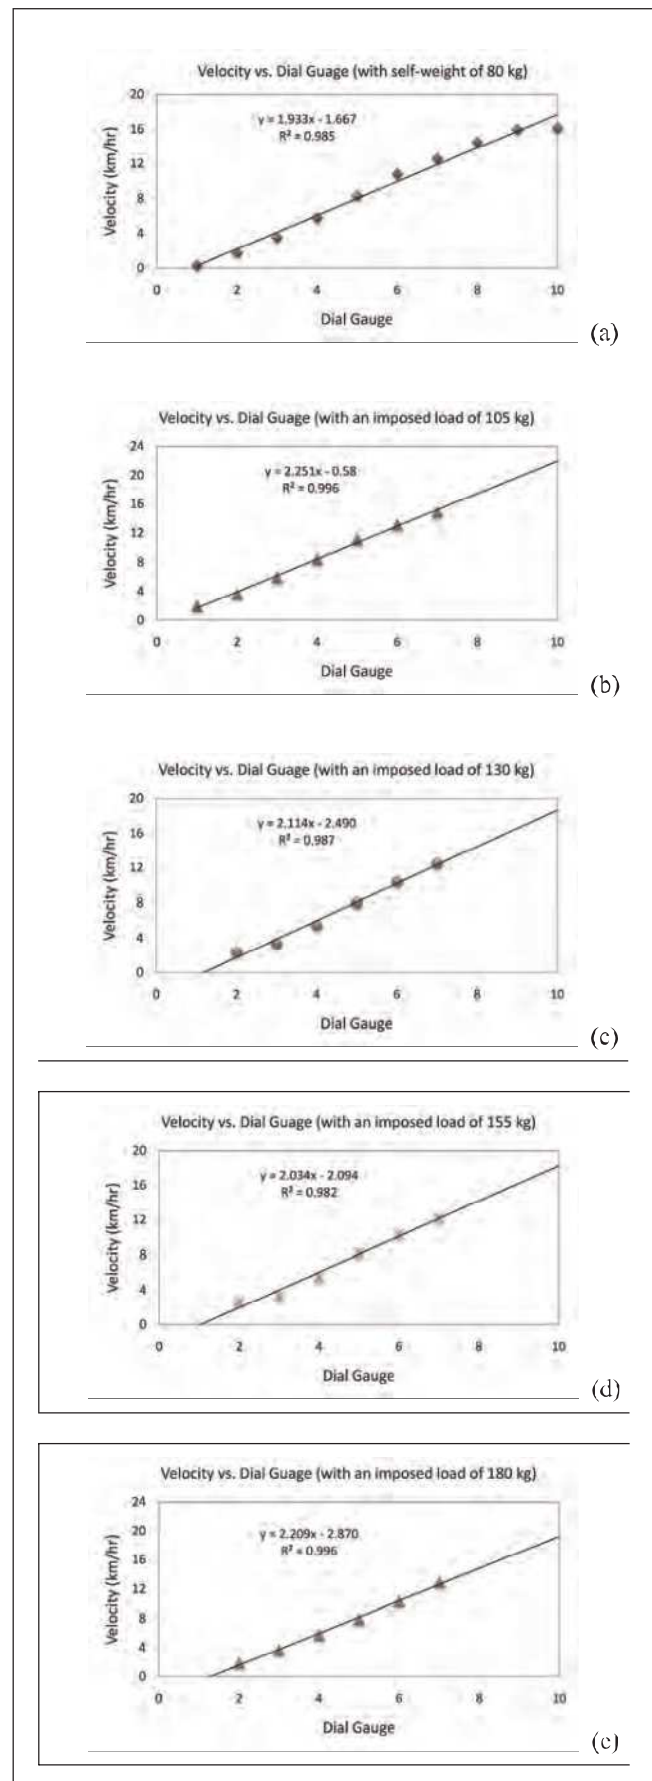
Figure 4: Velocity versus dial gauge with an imposed load of (a) 80 kg (b) 105 kg (c) 130 kg (d) 155 kg and (e) 180 kg

Calibration work was carried out to determine the speed for each dial number with a variable imposed load. The imposed load varied from 80 kg (self-weight of the wheel) to 180 kg. Five tests were conducted to determine the appropriate speed. The weights used in the calibration process were 80, 105, 130, 155 and 180 kg. Based on the calibration results in Figure 4, the dial gauge number 4 was used in the process of obtaining rut equations, because the velocity did not change significantly although the imposed load increased. Dial gauge 4 yielded a velocity of 6 km/hr, which was then adopted in the experiment.

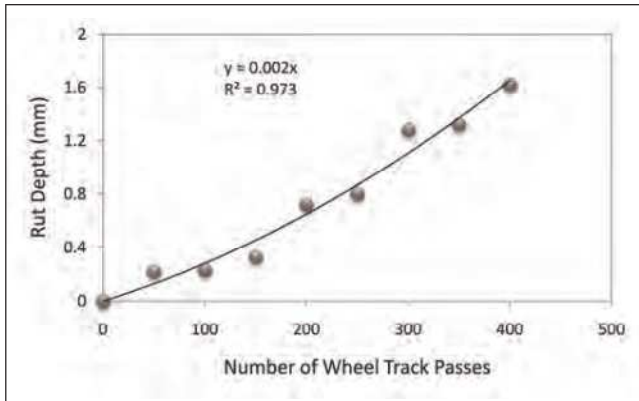
Figure 5: Rut depth versus number of wheel track passes on the straight stretch of ACW14

The rutting process on the straight section of ACW14 appeared to be relatively slow. There was no obvious rutting after 400 cycles. Maximum rutting after 400 cycles was 1.62 mm. A quadratic relationship was obtained between the rut depth and the number of wheel track passes on ACW14 on the straight stretch, as shown in Figure 5.

$$y = 4 \times 10^{-6} x^2 + 0.0024x \quad (1)$$

where y is the rut depth and x is the number of wheel passes. The polynomial regression for Equation 1 is $R^2 = 0.974$.

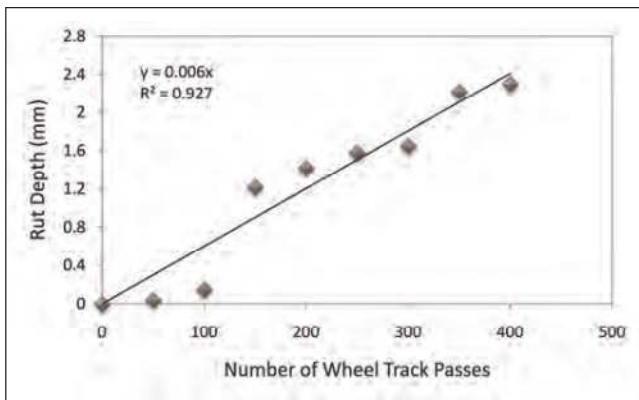
Figure 6: Rut depth versus number of wheel track passes on the corner stretch of ACW14

The rutting process on the corner section of ACW14 also appeared to be relatively slow. Rutting of more than 1 mm was observed after 300 wheel track passes. Rutting at the corner section was high due to the centrifugal force generated by the wheel as it cornered. Maximum rutting after 400 cycles was 1.60 mm.

A linear relationship was obtained between the rut depth and the number of wheel track passes on ACW14 at the corner stretch, as shown in Figure 6.

$$y = 0.006x \quad (2)$$

where the symbols are as previously defined. The linear regression for Equation 2 is $R^2 = 0.927$.

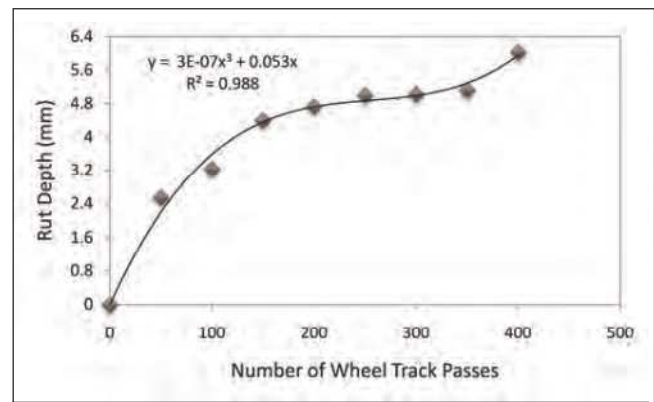
Figure 7: Rut depth versus number of wheel track passes on the straight stretch of ACW20

The rutting process on the straight section of ACW20 appeared to be relatively fast. Rutting of more than 2.5 mm was observed after 50 wheel track passes. Rutting on the straight section of ACW20 was high due to the poor compaction caused by using the vibrating plate compactor¹. When the machine is used for compacting asphalt, one of the problems that might run into is sticking or adhesion of the asphalt material to the bottom of the plate. This can lead to poor compaction and subsequently accelerates the rutting deformation of HMA wearing course.

Maximum rutting after 400 cycles was 6.03 mm. This type of rutting is classified as low severity. It is found that the rutting process of the ACW20 occurs relatively faster compared to ACW14 which could be due to lower degree of compaction as mentioned earlier.

A cubic relationship was obtained between the rut depth and the number of wheel track passes on the straight stretch of ACW20.

$$y = 3 \times 10^{-7} x^3 + 0.053x \quad (3)$$

where the symbols are as previously defined. The polynomial regression for Equation 3 is $R^2 = 0.988$.

where the symbols are as previously defined. The polynomial regression for Equation 4 is $R^2 = 0.940$. Figures 7 and 8 show the curves for rut depth versus number of wheel track passes for the straight and corner stretches of ACW20 respectively.

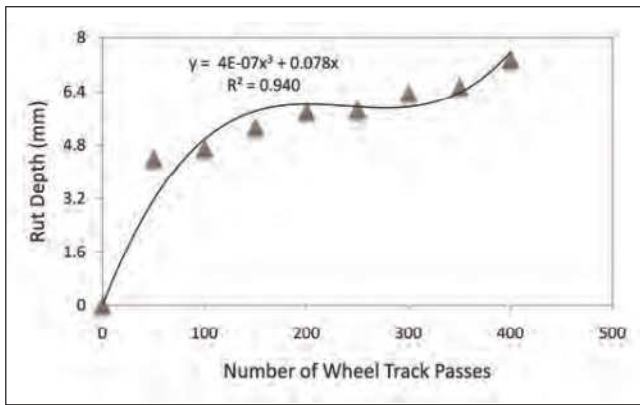
Figure 8: Rut depth versus number of wheel track passes on the corner stretch of ACW20

The rutting process at the corner section of ACW20 also appeared to be relatively fast. Rutting of more than 2.7 mm was observed after 50 wheel track passes. Rutting at the corner section of this mix was due mainly to the high centrifugal force generated by the wheel as it cornered and poor compaction using the vibrating plate compactor. Maximum rutting after 400 cycles was 40.4 mm. This type of rutting is classified as high severity.

A mathematical relationship was obtained between the rut depth and the number of wheel track passes at the corner stretch of ACW20.

$$y = 4 \times 10^{-7} x^3 + 0.078x \quad (4)$$

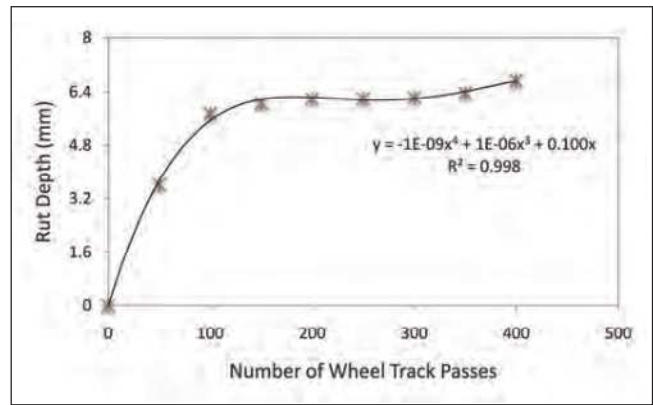
Figure 9: Rut depth versus number of wheel track passes at the joint between ACW14 and ACW20 on the straight stretch

The rutting process at the joint between ACW14 and ACW20 on the straight stretch appeared to be relatively fast. Rutting of more than 5.11 mm was observed after 50 wheel track passes. Rutting at the joints between these two mixes was generally due to the time of laying the ACW20. Since the ACW20 was laid a week later than the ACW14 without applying a tack coat, there was no proper adhesion between the existing wearing surface and the new bituminous wearing surface. Rutting at the joint between these two mixes could be caused by lower density induced by the lower mix temperature during compaction resulting in low tensile strength. Field studies showed that typical density of the HMA near a joint is at least two to three percent lower than the remaining pavement resulted in low tensile strength, coupled with oxidative hardening of the asphalt due to high voids in the mixture in the joint area [13]. It was observed that there was poor adhesion between ACW14 and ACW20. In addition, poor adhesion between asphalt and the aggregate can aggravate the problem adjacent and cause more rapid deterioration. Another factor contributing to rutting at the joint between the two mixes is the improper compaction carried out using the vibrating plate compactor. Maximum rutting after 400 cycles was 78.4 mm. This type of rutting is classified as high severity.

A mathematical relationship was obtained between the rut depth and the number of wheel track passes at the joint between ACW14 and ACW20 on the straight stretch:

$$y = -1 \times 10^{-9}x^4 + 1 \times 10^{-6}x^3 + 0.100x \quad (5)$$

where the symbols are as previously defined. The polynomial regression for Equation 5 is $R^2 = 0.998$. Figure 9 shows the curve for rut depth versus number of wheel track passes for the joint between ACW14 and ACW20 on the straight stretch.

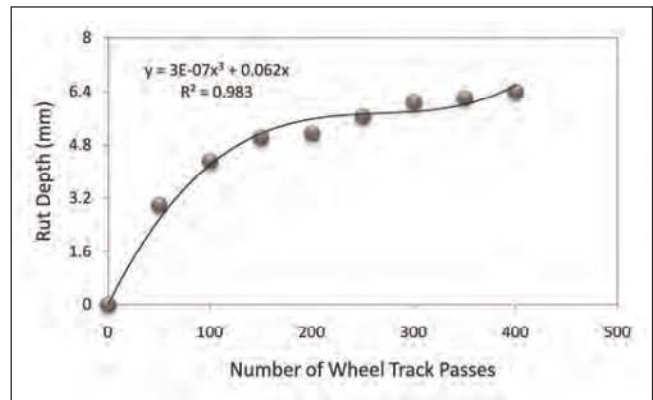
Figure 10: Rut depth versus number of wheel track passes at the joint between ACW14 and ACW20 at the corner stretch

The rutting process at the joint between ACW14 and ACW20 at the corner stretch appeared to be relatively fast. Rutting of more than 3.13 mm was observed after 50 wheel track passes. Similar finding was observed as previously mentioned in Section 3.2.3 and therefore, is not discussed for brevity. Maximum rutting after 400 cycles was 44.0 mm. This type of rutting is classified as high severity. A mathematical relationship was obtained

between the rut depth and the number of wheel track passes at the joint between ACW14 and ACW20 on the corner stretch:

$$y = 3 \times 10^{-7}x^3 + 0.062x \quad (6)$$

where the symbols are as previously defined. The polynomial regression for Equation 6 is $R^2 = 0.983$. The curve for rut depth versus number of wheel track passes for the joint between ACW14 and ACW20 at the corner stretch is shown in Figure 10.

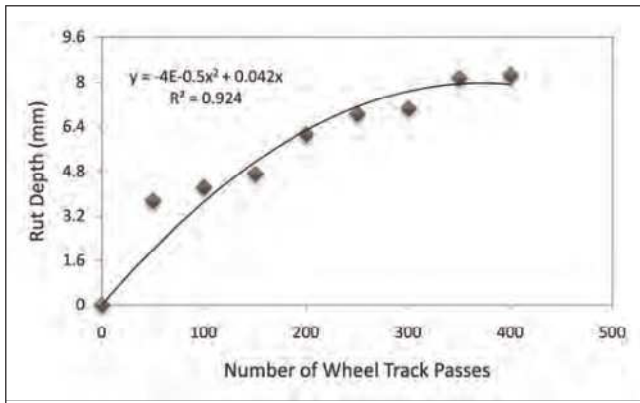
Figure 11: Rut depth versus number of wheel track passes on the straight stretch of ACW14 exposed to a temperature of 60°C

A quadratic relationship was obtained between the rut depth and the number of wheel track passes on a pavement exposed to a temperature of 60°C:

$$y = -4 \times 10^{-5}x^2 + 0.042x \quad (7)$$

where the symbols are as previously defined. The polynomial regression for Equation 7 is $R^2 = 0.924$. Meanwhile, Figure 11 shows the relationship between rut depth and number of wheel track passes on a pavement exposed to a temperature of 60°C.

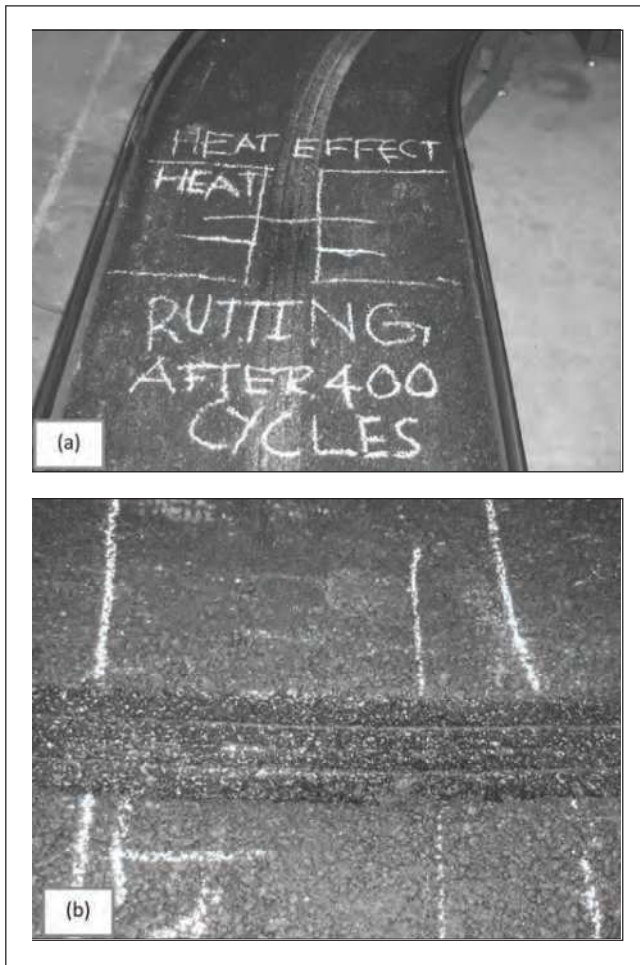
Figure 12: Bleeding and segregation of aggregates occurred after 400 cycles when ACW14 was subjected to a temperature of 60°C

To mimic the actual temperature experienced by a given pavement in practice, the test pavement section was heated to a temperature of 60°C. It was observed that the rutting process at this temperature was relatively fast. Rutting of 2.0 mm was observed after 50 wheel track passes. Since the softening point of binder is at 44°C and the pavement was tested at a temperature

of 60°C, bleeding and segregation took place. The imposed load applied on the pavement accelerated this bleeding and segregation and therefore led to rutting (Figure 12). Maximum rutting after 400 cycles was 10.4 mm. This type of rutting is classified as low severity.

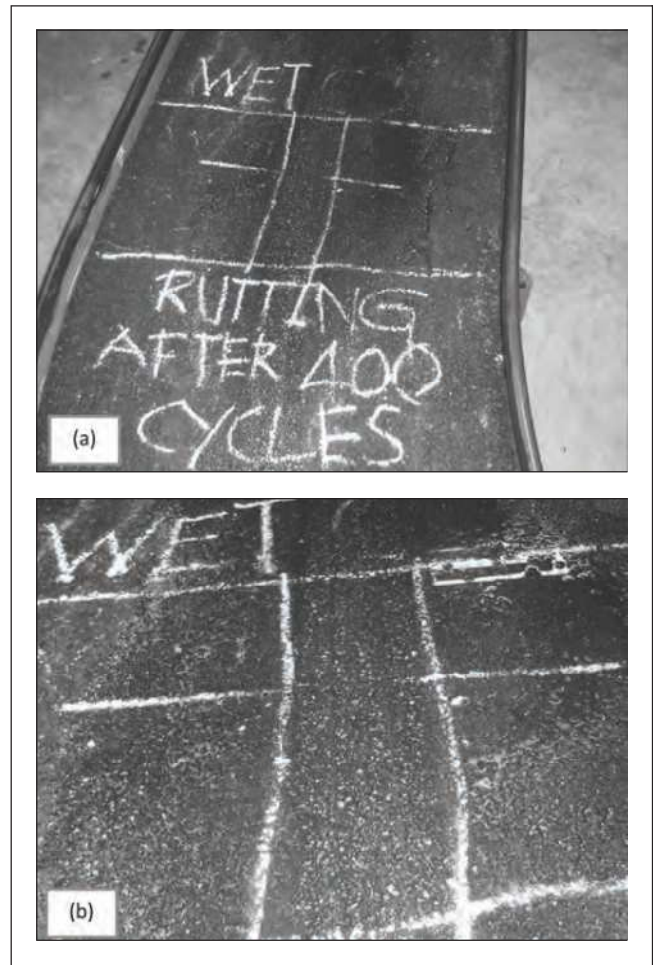
Figure 13: Stripping of aggregates occurred after 400 cycles when ACW14 was exposed to continuous wet conditions

The rutting was tested on pavement exposed to continuous wet and water-ponding conditions. It was observed that the rutting process under this environmental exposure was relatively slow. Rutting of 0.68 mm was recorded after 50 wheel track passes. Rutting under this environmental condition is accelerated by the presence of an air void. Water seeps through these voids and causes a stripping process to occur. Poor compaction accelerates the rutting phenomenon. Water further loosens the bonding of aggregates, causing them to displace horizontally, and therefore causes rutting to occur under the wheel path (Figure 13). Maximum rutting after 400 cycles was 4.0 mm. A quadratic relationship was obtained between the rut depth and the number of wheel track passes on pavement exposed to wet conditions:

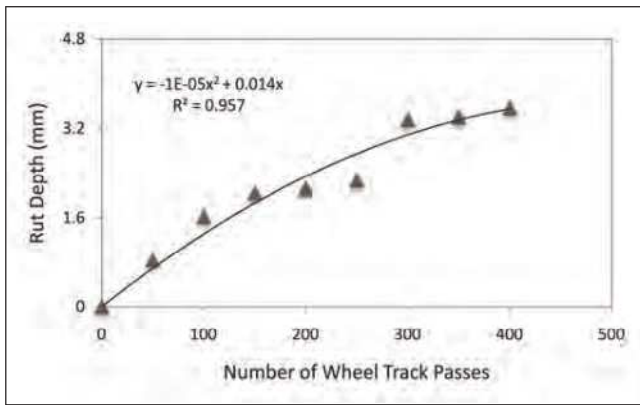
Figure 14: Rut depth versus number of wheel track passes on the straight stretch of ACW14 exposed to continuous wet conditions

$$y = -1 \times 10^{-5}x^2 + 0.014x \quad (8)$$

where the symbols are as previously defined. The polynomial regression for Equation 8 is $R^2 = 0.957$. Figure 14 shows the relationship between rut depth versus number of wheel track passes for the straight stretch of ACW14 exposed to continuous wet conditions.

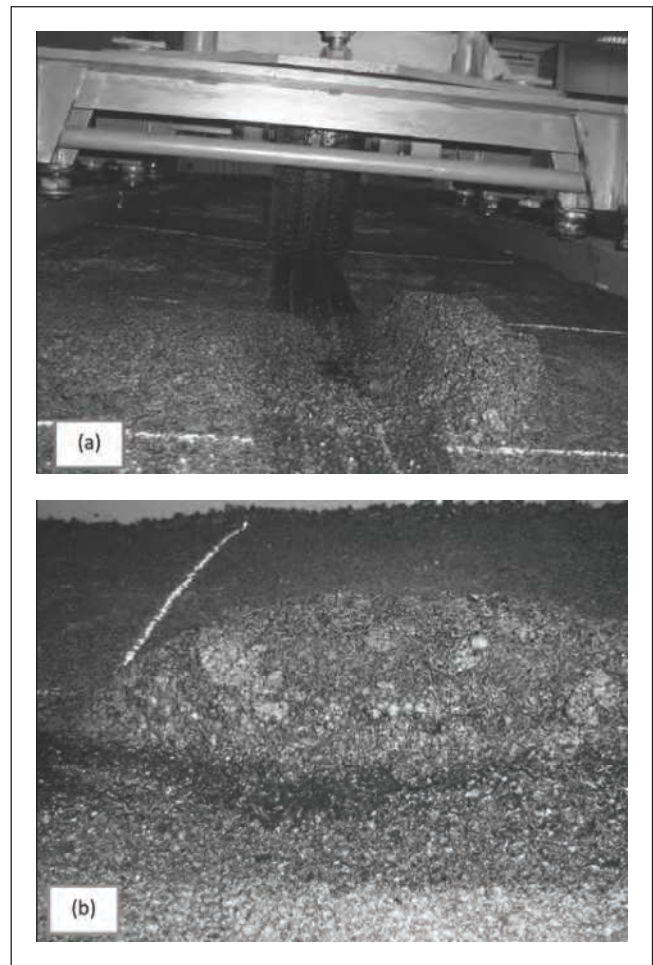
Figure 15: Severe rutting and discolouration occurred at the location where the pavement was exposed to petrol

The rutting process under exposure of petrol spillage was relatively very fast. Rutting of 37.27 mm was recorded after 50 wheel track passes. This type of rutting is classified as high severity. No further reading was taken because the pavement was severely damaged. The wheel track was slipped when passing through a section of pavement. Rutting at the petrol spillage area was very bad because petrol acts as a solvent and causes the asphalt to behave as “cutback asphalt”. When petrol is poured onto the pavement it actually dilutes the asphalt at room temperature and, in that particular moment, it becomes a liquid product. Hence, the pavement is not able to sustain the load because of losing the bonding between asphalt and aggregates. Therefore, lateral displacement occurs instantaneously when the load is applied, leading to severe rutting. This phenomenon is obvious in Figure 15 and no mathematical relationship was obtained because there was insufficient data.

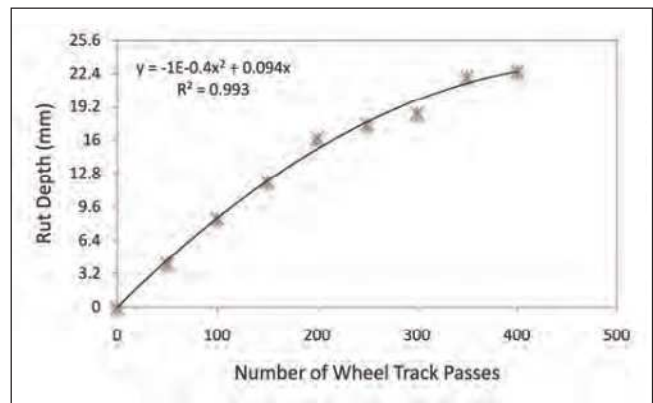
Figure 16: Rut depth versus number of wheel track passes on the straight stretch of ACW14 with diesel spillage

The rutting process at the stretch exposed to diesel appeared to be relatively fast. Rutting of more than 4.45 mm was observed after 50 wheel track passes. The factors contributing to rutting at this location are similar to those for petrol. Diesel acts as “cutback asphalt” whereby it liquefies the asphalt at room temperature, which consequently loses its capacity to bond with the aggregates, leading to rutting. Maximum rutting after 400 cycles was 21.6 mm. This type of rutting is classified as moderate severity.

A mathematical relationship was obtained between the rut depth and the number of wheel track passes at the location exposed to diesel:

$$y = -1 \times 10^{-4}x^2 + 0.094x \quad (9)$$

where the symbols are as previously defined. The polynomial regression for Equation 9 is $R^2 = 0.993$. A relationship between rut depth and number of wheel track passes for the straight stretch of ACW14 with a spillage of one liter of diesel is depicted in Figure 16. Meanwhile, Figure 17 shows rut occurrence at ACW14 exposed to diesel after 400 cycles.

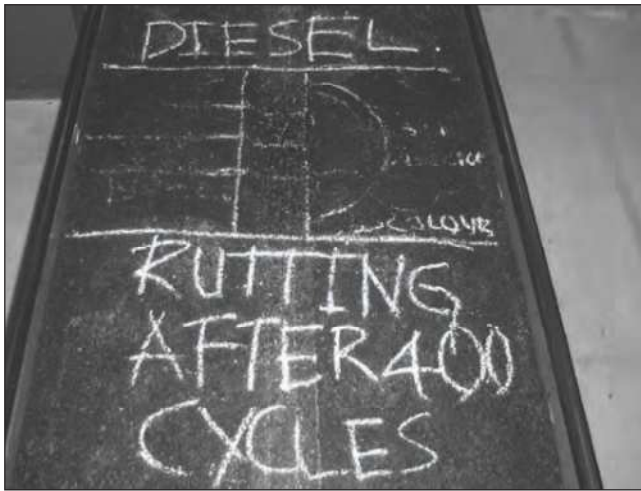
Figure 17: Rutting after 400 cycles at ACW14 exposed to diesel

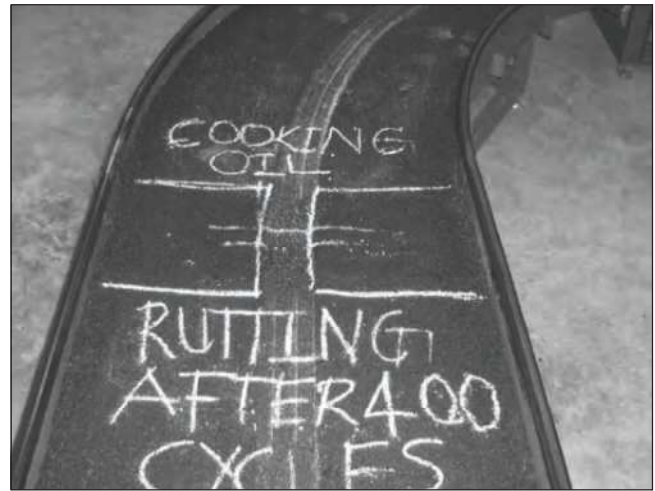
Figure 18: Rutting after 400 cycles at ACW14 exposed to cooking oil

The rutting process at the stretch exposed to cooking oil appeared to be relatively fast. Rutting of more than 4.1 mm was observed after 50 wheel track passes. The factors contributing to rutting at this location are the same to those for petrol and diesel. Cooking oil acts as “cutback” whereby it liquefies the asphalt at room temperature, causing the mix loses its strength and lead to rutting (Figure 18). Maximum rutting after 400 cycles was 58.0 mm. This type rutting is classified as high severity.

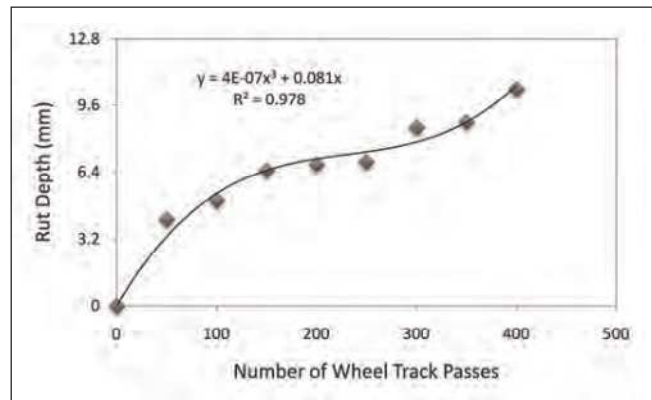
Figure 19: Rut depth versus number of wheel track passes on the straight stretch of ACW14 with cooking oil spillage

A mathematical relationship was obtained between the rut depth and the number of wheel track passes at the location exposed to cooking oil:

$$y = 4 \times 10^{-7}x^3 + 0.081x \quad (10)$$

where the symbols are as previously defined. The polynomial regression for Equation 10 is $R^2 = 0.978$. A relationship between rut depth and number of wheel track passes for the straight stretch of ACW14 with a spillage of one liter of cooking oil is depicted in Figure 19.
