Spot Weld Failure Mechanisms Due to Different Types of Loading Conditions

Dr. Aravinthan Arumugam

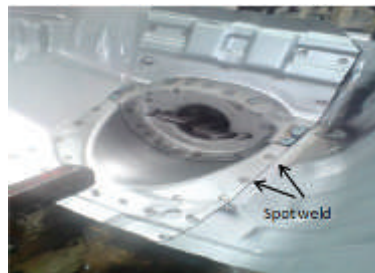
Figure 1: (b) Spot weld on automotive part.

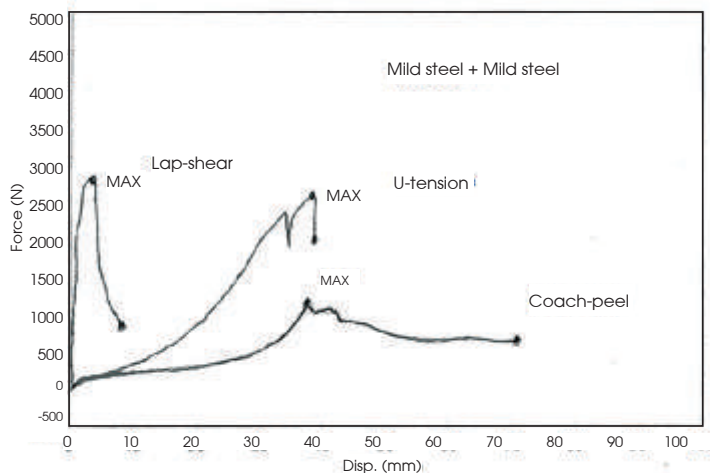
Figure 4 showed the force-displacement curves plotted when the samples were tested. Each test had five repetitions and the curves represented the average curve for each test.

Figure 4: Force-displacement curves for different loading conditions.

The peak load of the curve (MAX) was considered as the weld strength of the weld. The area under the curve represented the amount of energy absorbed to cause failure. The test results showed that lap-shear test gave the highest weld strength compared to the other test even though the spot welds for all samples were produced with the same welding schedule. The result above can be explained when failure mechanism is analysed in detail.

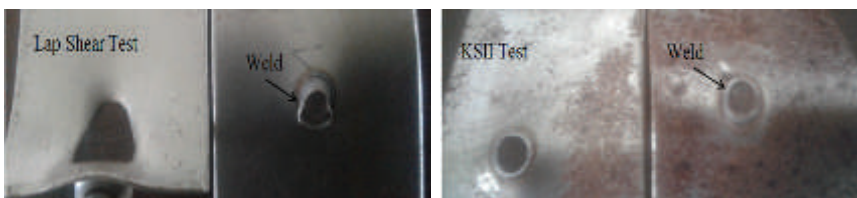
Figure 8 shows the spot weld failure by means of weld pull-out for lap-shear test, KSII test and coach peel test respectively. The figure clearly shows the weld pull-out failure is different in each test due to the difference in the failure mechanism. For KSII test, as the weld was pulled out from the other sheet due to thickness shearing around the weld circumference, the spot weld had a circular shape. For the lap shear test and coach peel test, the spot welds had two sections, a semi-circular section where metal necking occurred or metal tearing due to peeling action was initiated and the other section where a portion of metal from the other sheet remained intact at the circumference of the weld, due mainly to sheet tearing which occurred in both these tests. It was also observed from all the welds in Figure 8, that weld failure mainly occurred at the HAZ.

Figure 8: Spot weld pull-out failure in samples tested with lap shear test, KSII test and coach peel test.

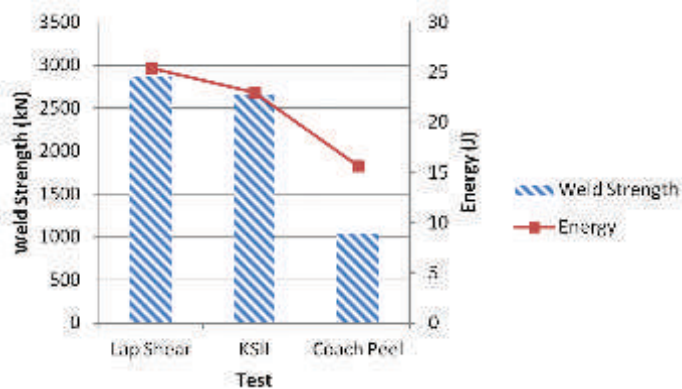
Figure 9 shows the weld strength and energy for failure for the welds tested with the three different loading conditions. Weld tested with lap shear test showed superior load bearing capacity and energy absorption capability. This could be due to the necking prior to failure which required huge amount of energy for the plastic deformation to occur. Coach peel test showed the lowest load bearing capacity and energy absorption as this test depended on crack initiation and propagation. Once crack was initiated, low energy was required to cause failure.

Figure 9: Weld strength and energy absorbed before failure for different tests.

- Weld tested with lap shear test shows highest load bearing capacity and energy absorption capability.
- Weld tested with coach peel test shows the largest displacement to failure. ■
