The Myths of Premature Failure of Plastic Pipes in Plumbing Applications

by Ir. A. H. Ung

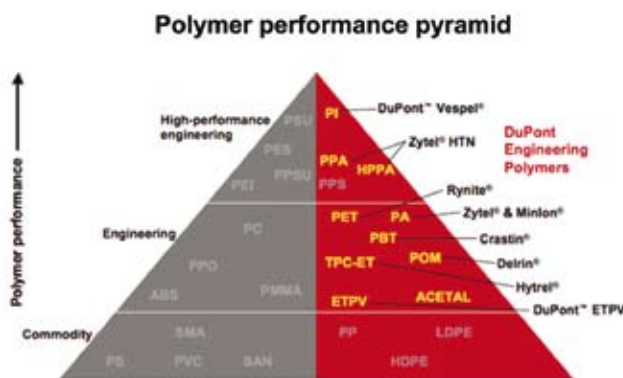
Figure 1: The DuPont polymer performance pyramid
(Source: http://www2.dupont.com/Plastics/en_US/Uses_Applications/)

Apart from the above classifications, thermoplastics are further classified into Commodity, Engineering and High Performance plastics. From the DuPont Polymer Performance Pyramid as shown in Figure 1, PVC, HDPE, PP (PPR, PPH) are Commodity Plastics, while ABS and PET are classified as Engineering Plastics. Thus, PVC, HDPE and PPR pipes are cheaper than ABS because of the difference in performances.

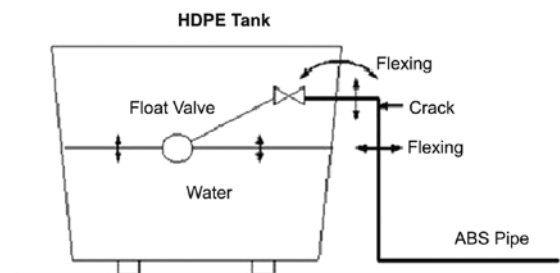
Figure 2: Common failure at inlet to HDPE tank
(Source: <http://www.azeetapipe.com>)

In landed residential properties, the most common failure occurs at the inlet pipe to the HDPE water tank. Normally, the symptom is the shearing of the elbow at the inlet area. Of course, the first reaction is that the material is brittle.

Upon closer investigation, one will invariably discover that there is flexing of the HDPE tank and the flexing forces are transferred to the inlet pipe which was not properly bracketed to prevent the shearing of the pipe. Figures 2 and 3 depict the flexing of the HDPE tank and the brackets required to prevent the shearing of the pipe. In some cases, the installer will claim that his installation has the

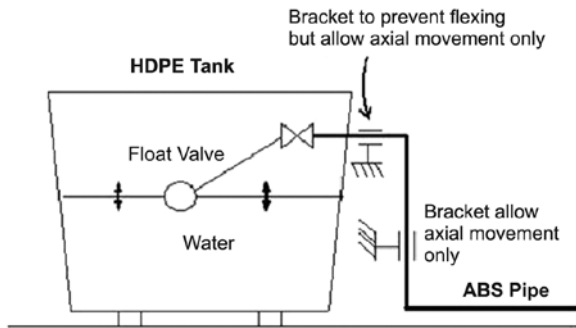
Figure 3: Recommended pipe bracket installation (Source: <http://www.azeetapipe.com>)

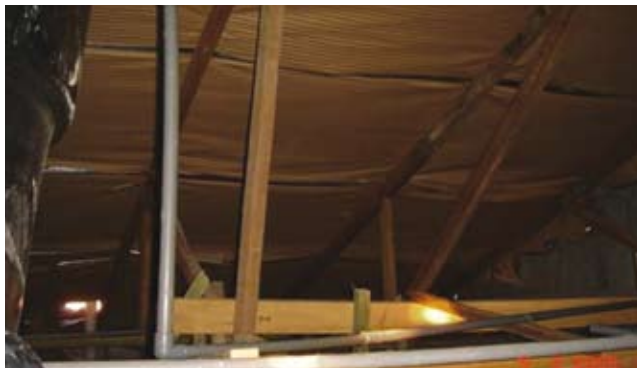
Figure 4: No proper bracketing (Source: <http://www.azeetapipe.com>)

necessary bracketing and yet the pipe still failed. Although there is some element of truth in that statement, one should determine if the brackets were installed properly in the first place? Let us take a look at Figures 4 and 5.

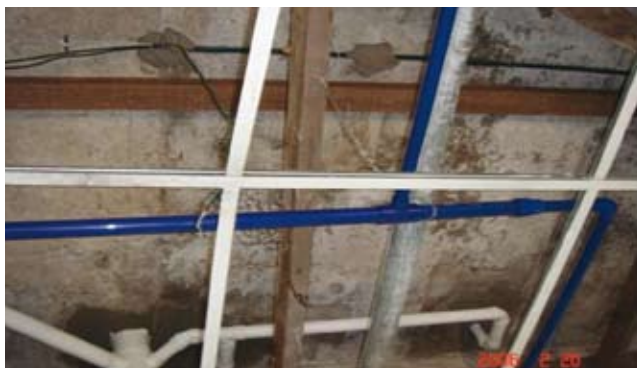
Figure 5: Thin wire used as pipe bracket (Source: <http://www.azeetapipe.com>)

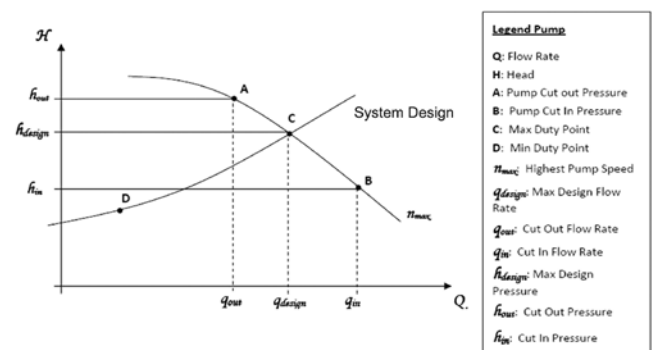
Figure 6: Single speed operation (Source: <http://www.azeetapipe.com>)

In Figure 6, the pump will operate between points A and B according to the performance curve whereas the system requirements are between points C and D. Clearly, there is a mismatch especially when the demand is at point D and the pump is operating at point B. In this situation, the velocity will be very high, and can sometimes be as high as 5ms⁻¹ to 6ms⁻¹, and will create a transient pressure that is much higher than the rated working pressure of the plastic pipe. There are cases where the transient pressure created is as high as 30 bars. Obviously, plastic pipes with a rated working pressure below that level will fail prematurely

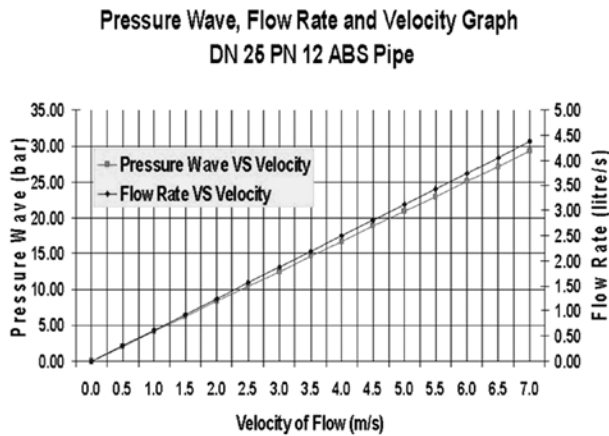
Figure 7: An example of the velocity of flow vs transient pressure or pressure wave created in an ABS pipe. (Source: <http://www.azeetapipe.com>)

(Figure 7 gives an example of the velocity of flow vs transient pressure or pressure wave created in an ABS pipe).

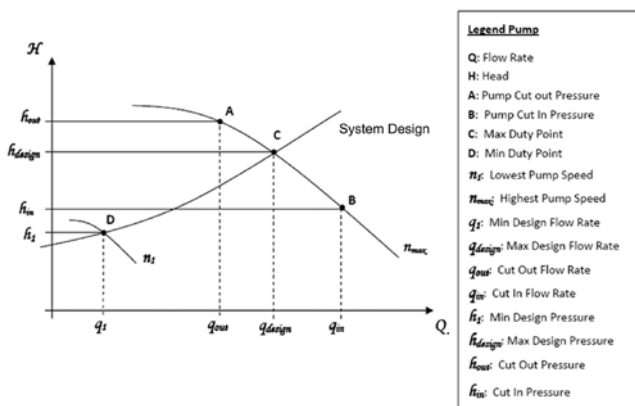
Figure 8: Variable Speed Operation (Source: <http://www.azeetapipe.com>)

The correct remedial action will be to match the pump operation to the design requirements all the way as shown in Figure 8. This can be achieved with the use of a variable speed pump with the lowest and highest speed, n_1 and n_{max} , calibrated to match duty points D and C respectively. This will ensure that whatever transient pressure created will be lower than the rated working pressure of the plastic pipes.

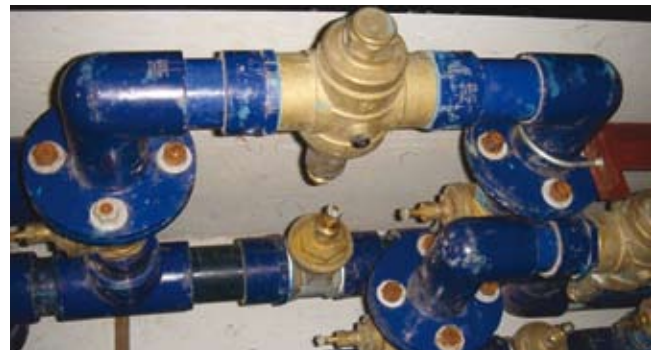
Figure 10: PRV installed without pressure gauges
 (Source: <http://www.azeetapipe.com>)

It is also important to note that a PRV must have the feature to cater for small usage, without which the PRV will start hunting when the situation arises. During this operating condition, the velocity of flow through the PRV can be as high as 14ms^{-1} (see Figure 10). Under this condition, the transient pressure created can be very high which, again, will lead to the premature failure of the plastic pipes.

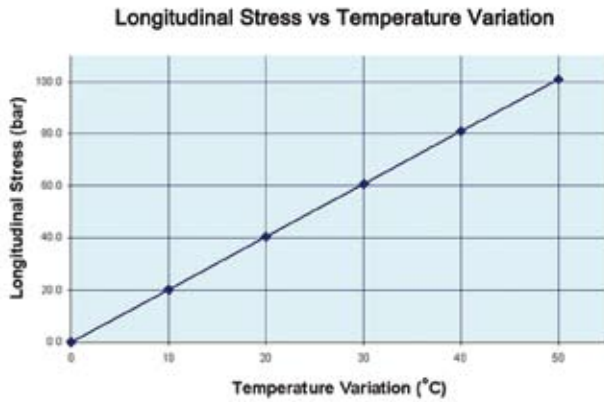
Figure 11: The relationship between the longitudinal stress of the ABS pipe against temperature
(Source: <http://www.azeetapipe.com>)

premature failure of the plastic pipeline. Figure 11 shows the relationship between the longitudinal stress of the ABS pipe against temperature.

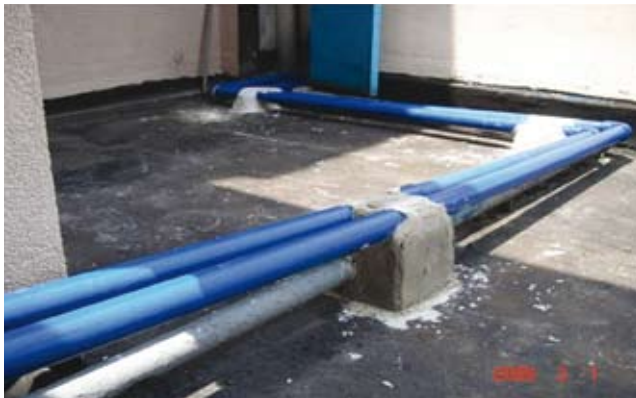
Figure 12: Exposed ABS pipe secured firmly with cement mortar
(Source: <http://www.azeetapipe.com>)

More often than not, the installer will install the exposed and unprotected plastic pipes, and secure it firmly with cement mortar (Figure 12). Such installation will definitely

kill the pipeline as there is no allocation for the pipeline to move in a pre-engineered manner.
