Percentage of Loss of Articulation for a Worship Place

By: Ir. Chuah Chin Hoon, P.Eng., MIEM

This paper briefly describes the calculation of percentage of loss of articulation (%ALcons) for this new church hall.

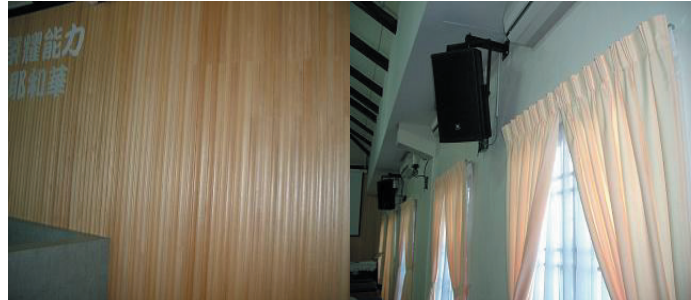
Figure 1

- (a) Air absorption from 1,000 Hz and above for a volume of 765.906 m³
- (b) Building structural absorption = 299.485 m²
- (c) Thin carpet = 147.79 m²
- (d) Wooden paneling over air space (stage wall) = 336.595 m², see Figure 1.
- (e) Curtain = 18 m², see Figure 2
- (f) Light upholstered seats = 45.174 m², see Figure 3
- (g) 50 mm rock wool wrapped with acoustic transparent fabric = 17.846 m²

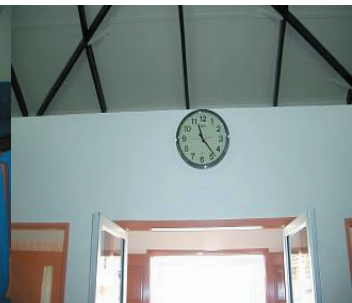
Note : This rock wool was laid and hidden in the empty space above the Entrance. When I said "hidden" is because they cannot be seen from outside, but can be reached by sounds

inside the hall. Figure 4 is the photo showing the rock wool was kept behind the clock.

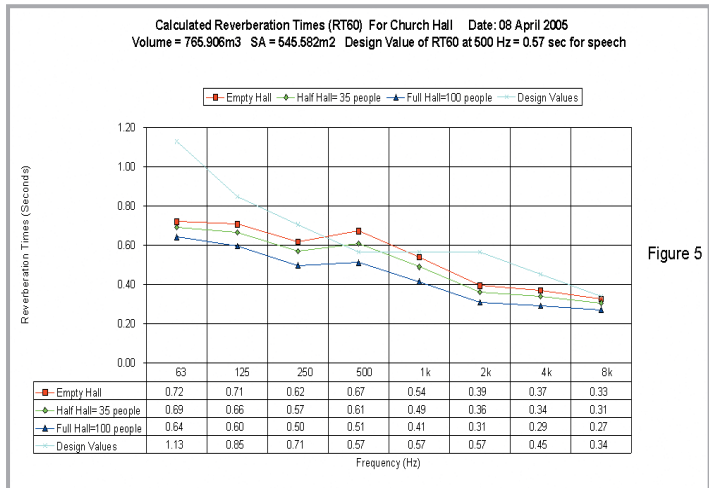
The calculated reverberation times (RT 60) at octave bands in empty hall using Eyring formula are shown in Figure 5 and tabulated below:

Frequency (Hz)	63	125	250	500	1k	2k	4k	8k
Q	0.72	0.71	0.62	0.67	0.54	0.39	0.37	0.33

Please note that they are all well below the designed values, except at 500 Hz.

6. CALCULATED REVERBERATION TIMES (RT60) AT OCTAVE BANDS, SEE FIGURE 5

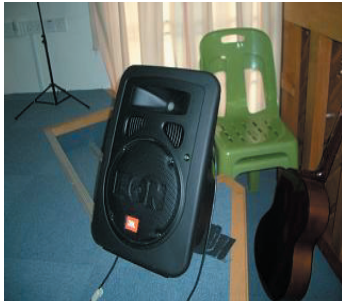
Figure 9

Owing to the fact that the stage is small, only one stage monitor model JBL EON 10 G2 speaker, see Figure 9, was provided on stage. This speaker has dispersion angles of 90 degrees (H) x 90

degrees (V), with an SPL of 117 dB at 1m at rated power. Since it is an active speaker, it can be used, if necessary, as a standby unit, in case the main system fails.

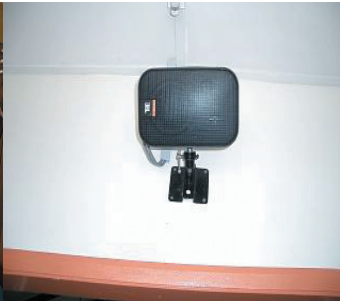
Figure 10

Three units of JBL Control 1, were installed on walls in Control Room, Entrance, and Mother’s Care Room, see Figure 10, to provide certain amount of sound to these areas.

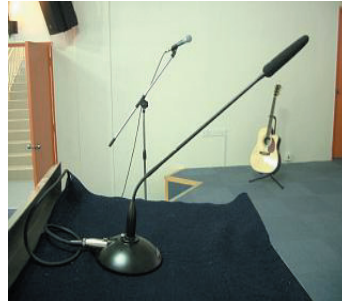
Figure 11

After completion of the installation, several condenser microphones with goose-neck were tested. Finally, the model Sennheiser MK 36 with super-cardioid directional characteristic was selected.

(a) Altar microphone: Sennheiser short-gun microphone type MK 36, see Figure 11,

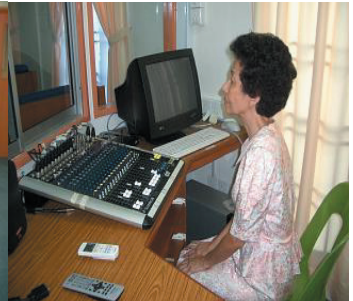
- (b) Dynamic microphone: Shure Beta 58, Shure SM 58 and Beyerdynamic M700TG
- (c) Wireless microphone: Shure UHF wireless microphone system EUT24BETA58 ,
- (d) Mixing Console: Soundcraft M12, see Figure 12
- (e) Power amplifier: Crown Xls 620
- (f) Graphic equaliser: Rane ME 60

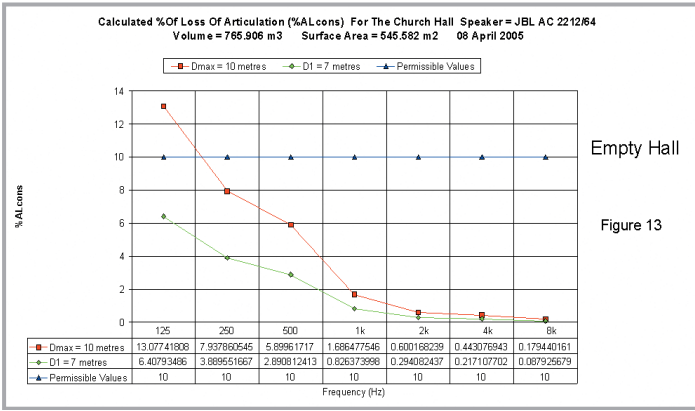
Figure 13

Based on the values of “Q” of wall speakers JBL AC 2212/64 given by the manufacturer and the calculated RT 60 as stated in item 6 above, the percentage of loss of articulation (%ALcons) at octave bands for the wall speakers at distances of 7 and 10 metres respectively away from them were calculated as shown in Figure 13. They were further tabulated as follows:

Frequency (Hz)	125	250	500	1k	2k	4k	8k
%AL cons at 7m	6.4	3.88	2.89	0.82	0.29	0.217	0.087
%AL cons at 10m	13.07	7.937	5.89	1.68	0.60	0.443	0.179

It is noted that they are all well below the permissible value of 10% and it, therefore, clearly shows that good speech intelligibility can be obtained inside the whole Hall.

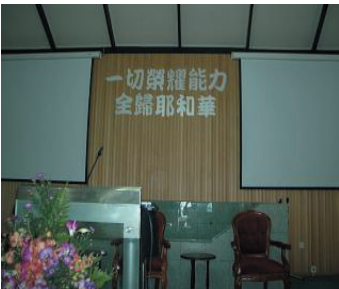
Figure 15

Just for information, two 8' x 8' motorised screens had been installed at both sides of the rear wall, see Figure 15, with two video projectors installed below the roof, see Figure 16.

The up and down of these two video screens could be controlled either at the front side wall or in the Control Room.
