Investigation of Pantai Punggur Coastal Erosion by using UAV Photogrammetry

Mohammad Ikhmal Siddiq¹, Mohd Effendi Daud¹, Masiri Kaamin², Mardiha Mokhtar², Amin Shah Omar²,
and Nguyen Anh Duong³

¹Faculty of Civil Engineering and Built Environment, Universiti Tun Hussein Onn Malaysia

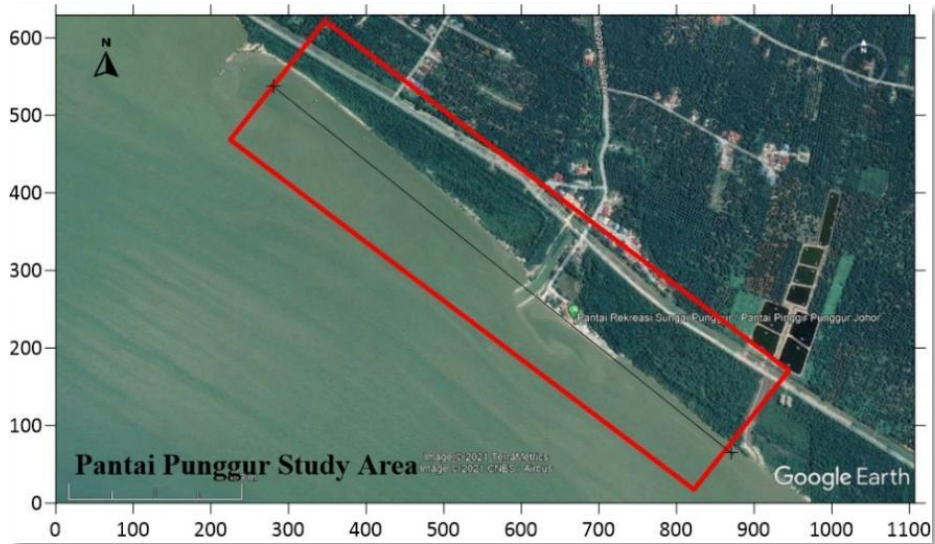
Figure 1. The study area of Pantai Punggur (Image from Google Earth).

The west coast of the Peninsular Malaysian shore is prominently characterized with mud and is flat with mangrove vegetation due to wind shield by the Sumatera [14]. The wave that has occurred is usually rising from 1.5 m to 2.5 m high, although the tide is different and appears to increase too. This effect can be caused by global warming. Global warming has changed the weather and affect the state of sea water to 16; thus, making the height of the wave and tide higher than the previous one. Therefore, this paper aims to study the shoreline corrosion rate for a year from August 2020 to August 2021 by using Unmanned Aerial Vehicle (UAV) with a two-kilometer shoreline coverage, as shown in Figure 2.

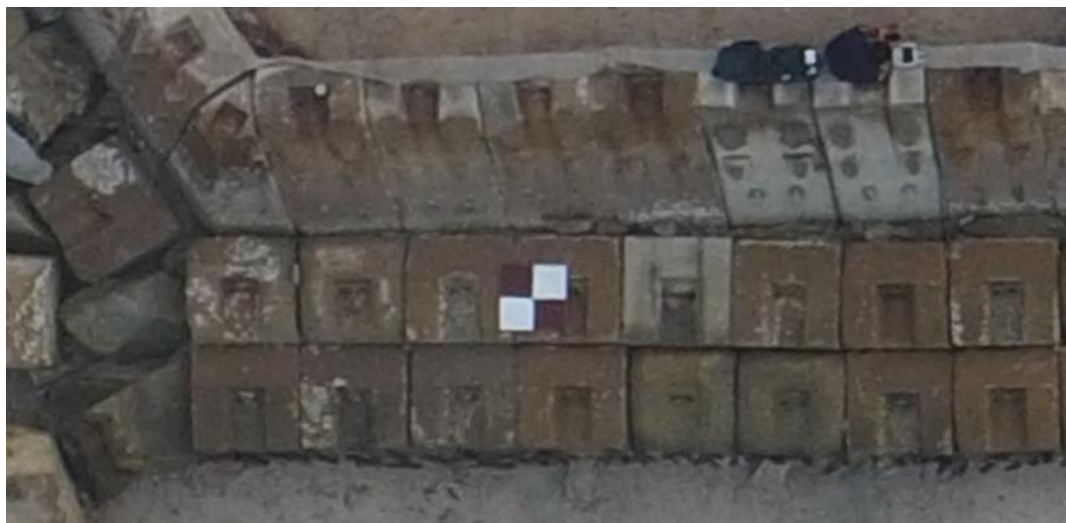
Figure 3. Ground control point placed at the Labuan Block on Pantai Punggur.

While geospatial data processing takes place, GCPs are coupled to geo-referenced images to classify real-world locations [16]. Ground control points are something that may easily be identified in photographs. They commonly resemble a small section of a checkerboard. The GCPs are commonly black and white because high contrast patterns are simpler to identify [17]. Figure 3 shows the ground control point used in this study.

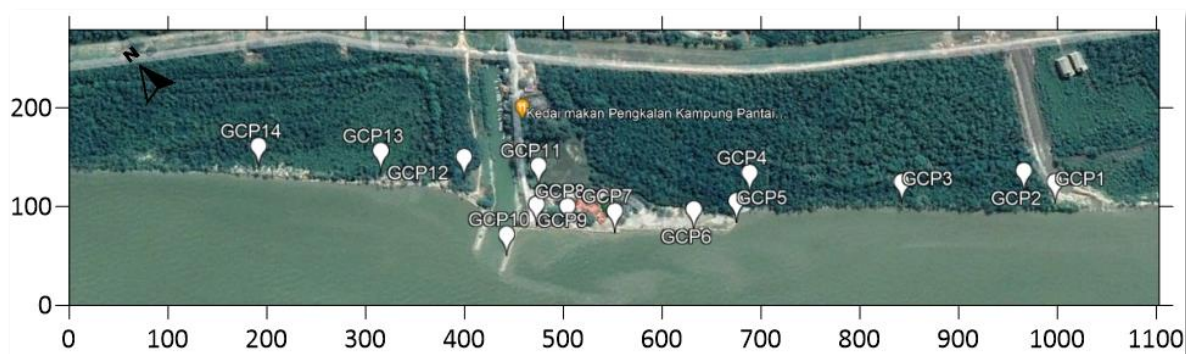
Figure 4. The location of GCPs along the shore of Pantai Punggur.

There are 15 GCPs that have been placed throughout the shoreline of Pantai Punggur. The GCPs are being used in order to increase the accuracy of the shoreline generated by the software and to ensure the orthomosaic map generated by the software are being accurately geolocated. The distances of GCPs are 200 metres apart and are being placed at only accessible points. The conditions along the shoreline of Pantai Punggur are full of mangrove trees and mud, so only a few selected points can be used as GCP points. Figure 4 shows the placement of the GCPs along the shore of Pantai Punggur.

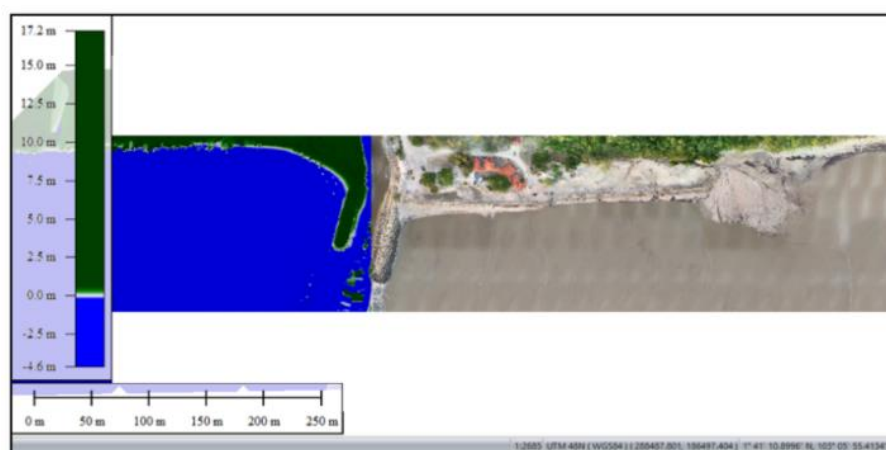
Figure 7. NDVI Layer in Global Mapper to determine shoreline.

Figure 7 shows the NDVI layer for the whole orthomosaic images. This Figure 7 has two overlap layers which are orthomosaic layer and NDVI layer. NDVI works as a filter that could present the orthomosaic features in land and water features [21]. This filter allows the process to differentiate the land and water features and being represented as the shoreline in the orthomosaic. The white line indicates zero (0) metre of water level which also being marked as the shoreline in the orthomosaic [22].
