Condition Monitoring of Power Cables

by Ir. Mohd Raffi bin Samsudin, Dr. Ir. Ahmad Basri Abdul Ghani, Ir. Huzaini Shafie Abd. Halim , Ir. Radzlan Hisham , Ir. Zairul Aida Abu Zarim , and En. Wan Zakaria Wan Kamarudin

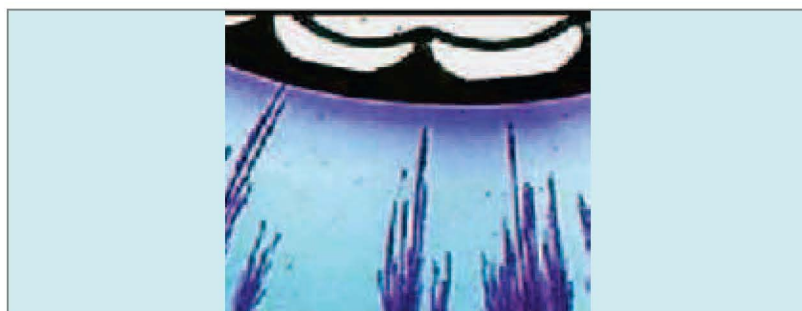
The dielectric dissipation test is done to assess the condition of the XLPE. A degraded or contaminated XLPE will have a higher loss factor, and thus, it can be revealed through this test. The insulation integrity of the XLPE cable is influenced by the presence of moisture and/or water tree as well as aging. Figure 1 shows the typical water tree in the XLPE cable.

Figure 1: Typical Water Tree in Power Cables

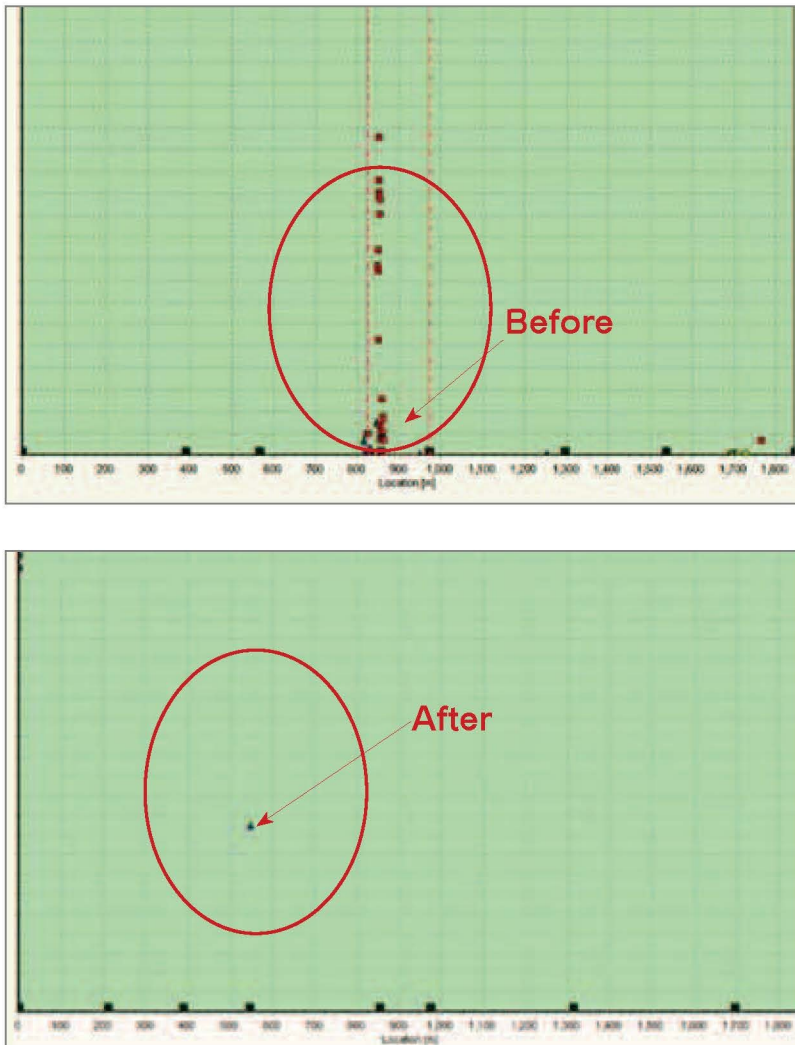
Red		Yellow		Blue	
	Before	After	Before	After	Before	After
Ground Noise [pC]	142	3	162	27	148	51
PDIV [kV RMS]	5.1	5.7	6.4	8.2	4.5	6.3
PDEV [kV RMS]	5.6	5.6	5.6	-	5.9	8.2
PD max. Uo [pC]	17200	234	107	0	580	95
No. of PD events Uo [N]	34	2	4	0	27	1
PD max. 1.3Uo [pC]	42100	590	145	74	3050	110
No. of PD events 1.3 Uo [N]	24	13	8	1	17	2
Dielectric Absorption Ratio (DAR)	1.32	1.58	1.15	1.23	2.2	1.12

After the repair work was done, the PD was repeated. The amount of PD was reduced significantly at the same location. This concludes that the condition assessment performed at Site A had managed to save the utility from a breakdown loss.

Figure 5: PD level before and after the repair
