Wearout Reliability and Intermetallic Compound Diffusion Kinetics of Au and PdCu Wires Used in Nanoscale Device Packaging

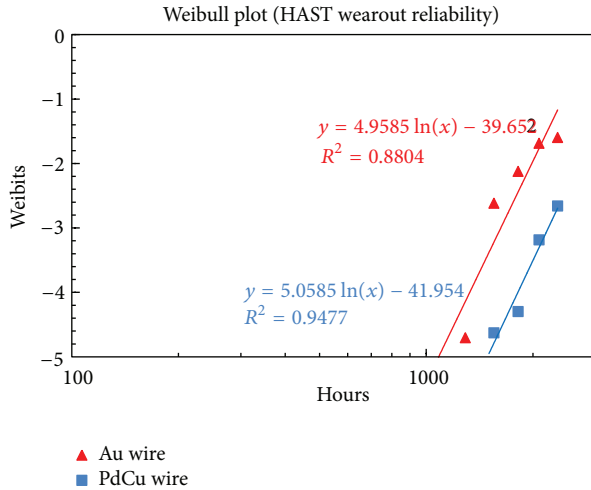
FIGURE 2: Biased HAST (130°C, 85% RH, 3.6 V Bias) Weibull plotting and its characteristics of PdCu and Au wires used in 110 nm device FBGA 64 package.

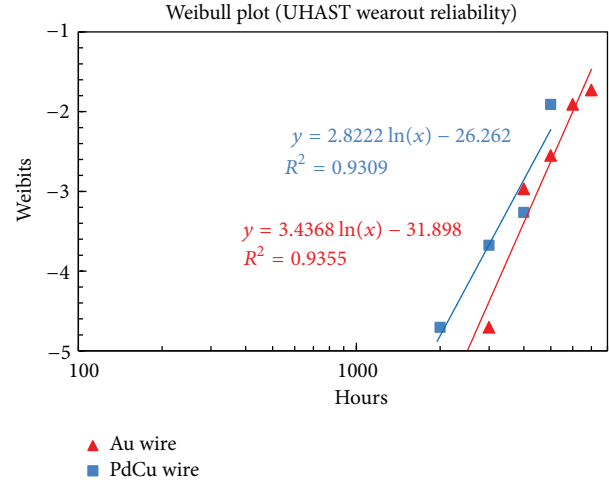
FIGURE 3: Unbiased HAST (85% RH, 130°C) Weibull plotting and its characteristics of PdCu and Au wires used in 110 nm device FBGA 64 package.

However, PdCu wire exhibits slightly lower UHAST stress compared to conventional Au wire as shown in Figure 3. This could be attributed to the variation of PdCu ball bond integrity in semiconductor assembly. However, both PdCu and Au wire legs in UHAST stress still far exceeded the industrial JEDEC standard of 96-hour surviving hours. The first hour rate to failure of PdCu and Au ball bonds are at 3000 hour and 4000 hour, respectively. This indicates that the bare Cu wire coated with palladium plays an important role in improving its biased HAST wearout reliability compared to Au ball bond in FBGA package with longer surviving hours.

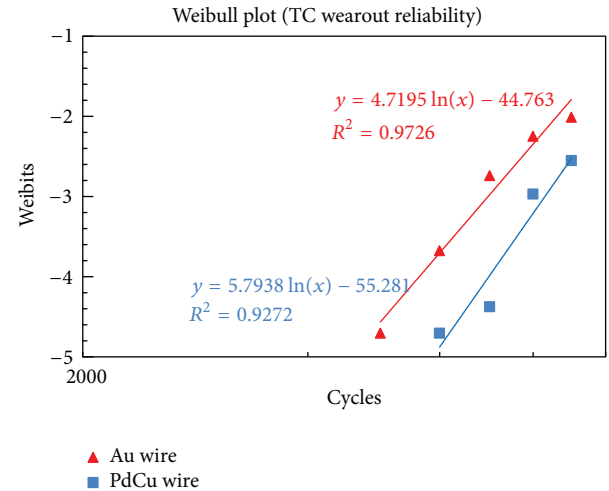
FIGURE 4: Component level temperature cycling (−40°C to 150°C) Weibull plotting and its characteristics of PdCu and Au wires used in 110 nm device FBGA 64 package.

Thermomechanical degree of Au and PdCu ball bonds was investigated through Temperature Cycling, (−40°C to 150°C condition TC). Figure 4 reveals wearout reliability plots

fitted to Weibull distribution of both wire types. PdCu ball bonds shows better and larger cycles to failure compared to Au ball bonds on 110 nm device FBGA 64 package. PdCu ball bonds still exhibit longer cycle-to-failure compared to Au ball bonds in terms of thermomechanical stress, and PdCu is believed ball bond with better first ball bond integrity and able to withstand longer cold and hot cycling test with material contraction and expansion.

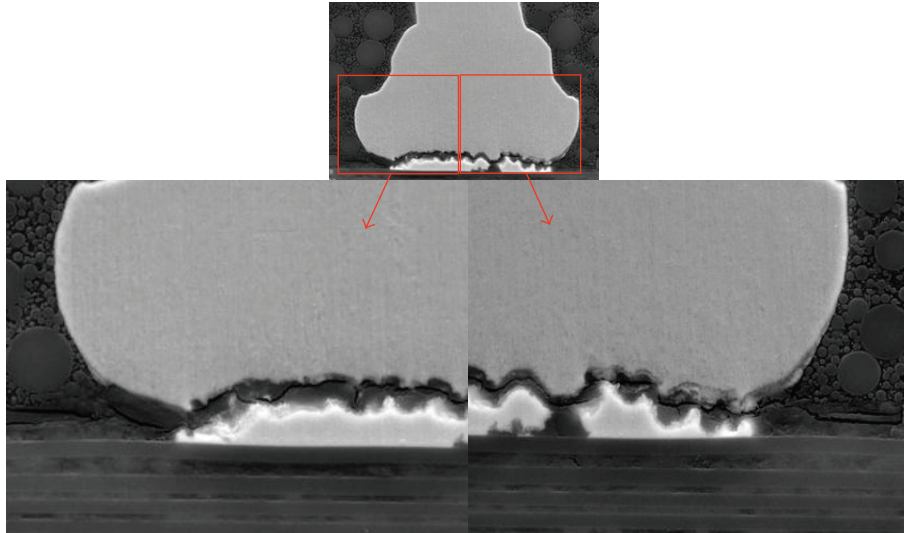
FIGURE 5: Typical AuAl IMC microcracks post extended HAST stress (1553 hr).

due primarily to Kirkendall voiding [27–31]. In our study, the typical AuAl IMC interface corrosion and microcracking are indicated in Figure 5 after biased HAST 1553 hours. The whole fineline AuAl IMC microcracking occurs along the whole AuAl interface.

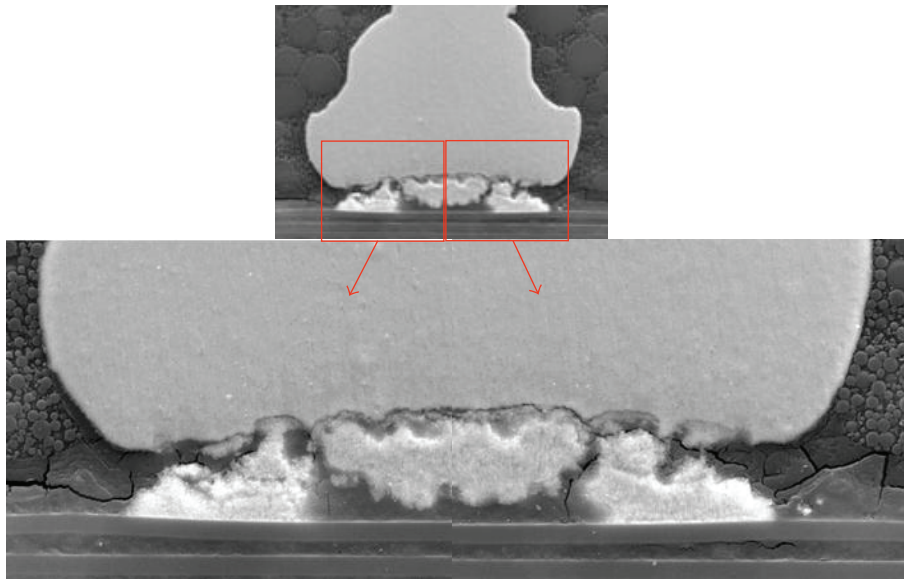
FIGURE 6: Typical AuAl IMC microcracks post extended UHAST stress (2000 hr).

AuAl IMC microcracking is also observed in post UHAST-2000 hour. The failure mode is similar to post biased HAST 1553 hr for Au ball bonds on Al bondpad (as depicted in Figure 6).

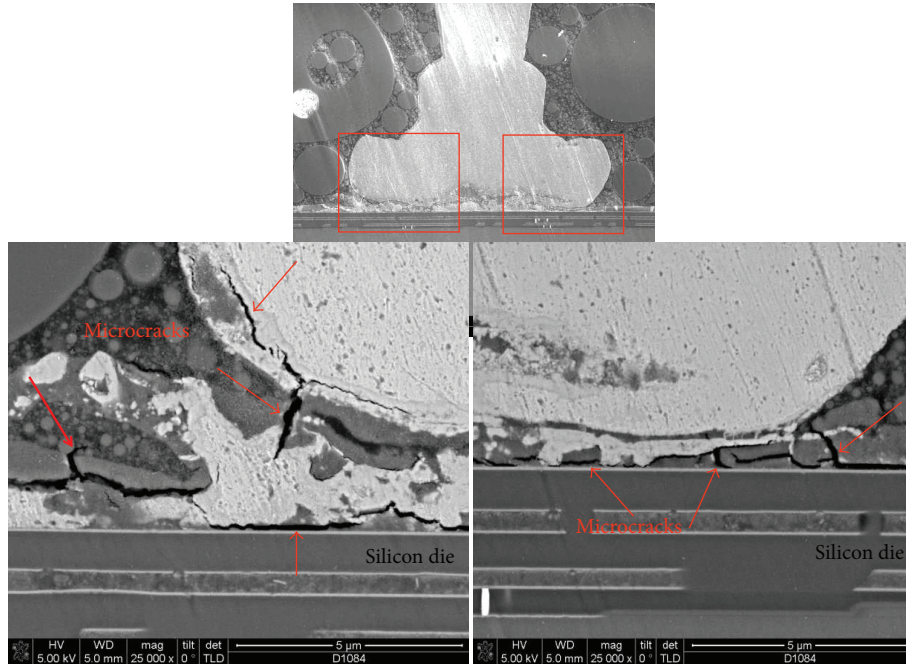
Figure 7 illustrates the typical biased HAST 1817 hours CuAl IMC interface corrosion. The same failure phenomenon was observed after HAST as well as UHAST stresses, and it is most probably attributed to Cl^- attacking the edge of Cu ball bond region. Hydrolysis of IMC and $AlCl_3$ (intermediate product) under moisture environment forms aluminium(III)

FIGURE 7: Typical CuAl IMC microcracks post extended HAST stress (1817 hr).

A representative PdCu ball bond cross-section SEM image confirms CuAl interface fineline cracking as shown in Figure 7. The fineline cracking would probably cause electrical opens in HAST stress for PdCu. The failure mechanism of Au ball bond is found similar to PdCu ball bond with similar fineline microcracking along the AuAl IMC region and caused electrical opens. Similar edge Cu ball bond microcracking is observed in post-UHAST 1000 hour opens of PdCu ball bond on Al bondpad (as shown in Figure 8).

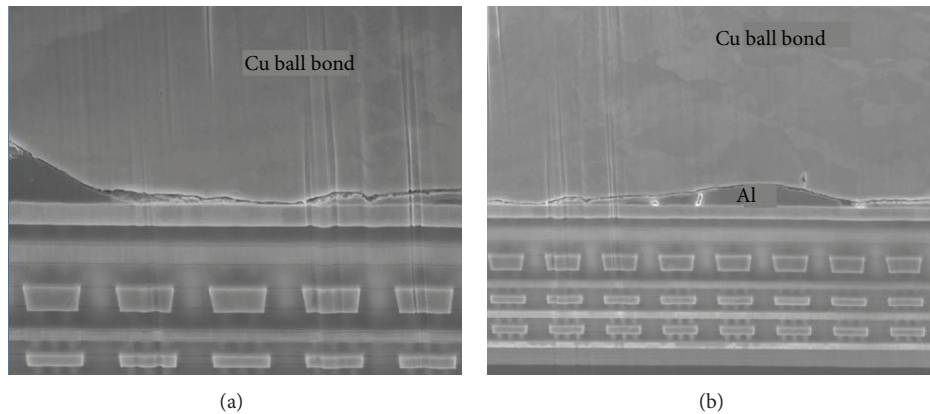
FIGURE 8: Typical CuAl IMC microcracks post extended UHAST stress (1000 hr).

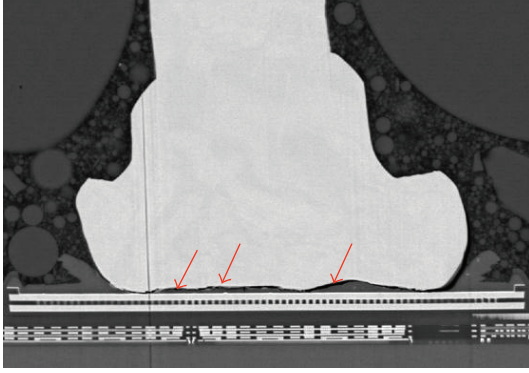
Representative PdCu ball bond cross-section SEM image confirms CuAl interface fineline cracking as shown in Figure 9. The fineline cracking would probably cause

FIGURE 9: Typical CuAl IMC microcracks post extended TC stress (7000 cyc).

electrical opens in TC stress for PdCu. The failure mechanism of Au ball bond is found similar to PdCu ball bond with similar fineline microcracking along the AuAl IMC region and caused electrical opens. The fineline cracking after TC is due to the CTE mismatch between silicon die and Au and PdCu ball bonds under TC conditions (-40°C to 150°C) [8].
