## CHAPTER 4

### RESULT AND DISCUSSION

#### 4.1 Troubleshooting The Hardware and Software .

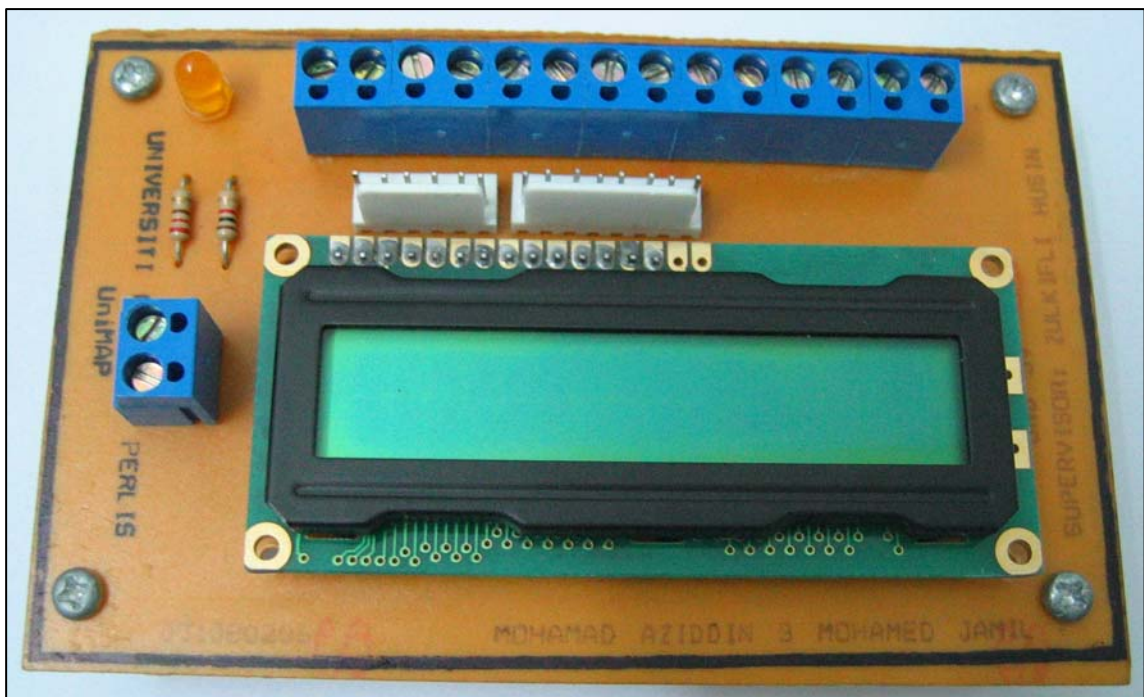
**Figure 4.3:** LCD Display Board

Figure 4.1, Figure 4.2 and Figure 4.3 are the result of the PCB fabrication. Before the overall system is functioning, the transmitter and receiver circuit are malfunction and need to be troubleshoot. An analysis is done on all circuits by examine the circuits diagram and its layout respectively. The first error detected is the IC LM7805 structure. This device acts as a voltage regulator which convert any voltage value supplied to the device and produce a constant 5V output voltage The typical pin configuration is the Voltage In (Vin) at pin 1 , Ground (GND) at pin 2 and Voltage Out (Vout) at pin 3. Unfortunately, the device is mistakenly selected which is the different type during the schematic drawing at Capture CIS. Its Vout is at pin 2 and GND is at pin 3. The solution is by drilling a new hole at the nearest device at the PCB and external wiring is done. This error has made an IC AT89S52 burned due to over voltage load.

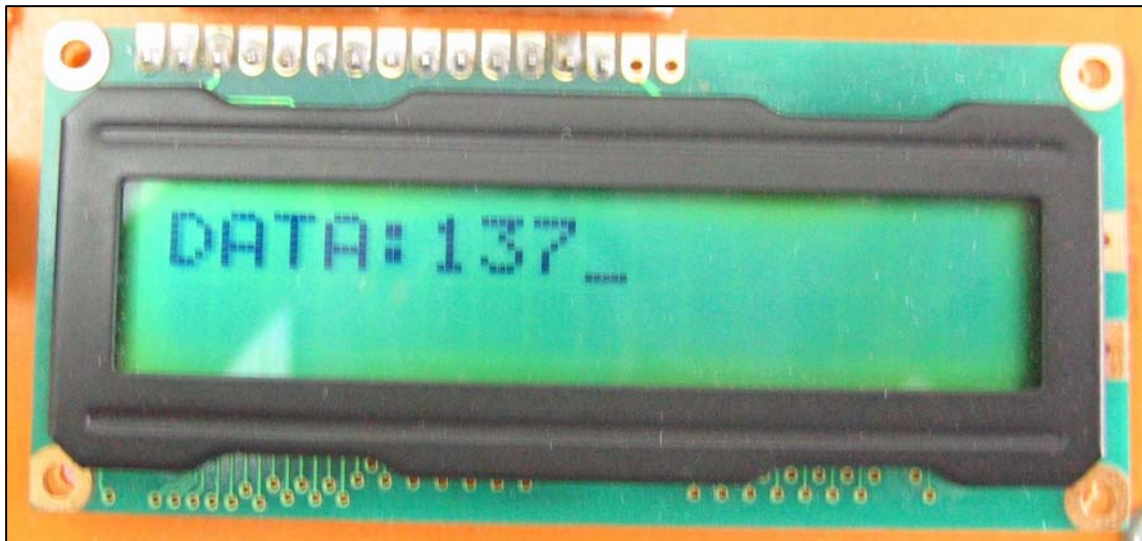
**Figure 4.9:** LCD Board Functioning

As the board is able to download the HEX file, the entire hardware is being integrated and the program is being downloaded into the respective transmitter and receiver microcontroller. One major error has been detected on the transmitter part where the ADC is failed to generate the digital output. So, another troubleshoot is done to identify the problem. After a lot of analysis, problem is that the program to activate the ADC is instable. The programming is based on the ADC0816 datasheet and the books references. The pressure is stress on this matter, examine the program one by one and finally the problem is solved. Moreover, the display devices are functioning which is the LCD and the GUI as shown at Figure 4.8 and Figure 4.9 while Figure 4.10 shows the data being saved in a notepad.
