External Patch Fillet Repair for Sulphur Recovery Unit of Petroleum Refinery Plant

In this project, the method of repairing the SRU wall due to thinning is presented. Routine inspection detected irregularities on the part of the SRU reheater external shell wall. In order to avoid future unplanned operation disruption, the repair was performed according to codes and standards.

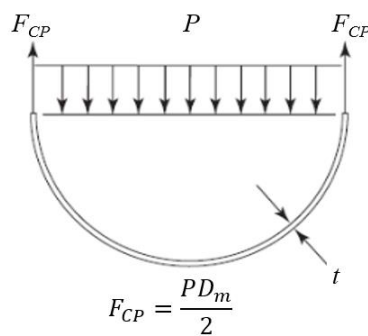
The required repair surface is a shell with a cylindrical shape. Hence, the plate is subjected to internal pressure load, which are in circumferential and longitudinal component load. The circumferential load calculation is given in Equation (2) and Figure 3.

Figure 3. Illustration of a plate subjected to internal pressure.

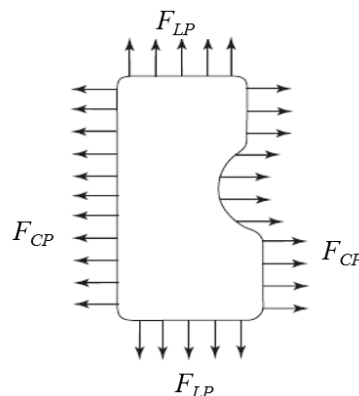
Knowing that the internal design pressure is set to 353 kPa while the diameter at mid-wall of component is 1000 mm. Thus, the calculated total circumferential force from all loads is 176520 N/mm. Meanwhile, the calculated longitudinal force to the internal pressure is 88259.8 N/mm. The method of calculating the longitudinal force is as in Equation (3) and the direction of the relevant forces is depicted in Figure 4.

Figure 4. Illustration of a plate subjected to internal pressure.
