Comparative Study of Corrosion Behavior of AA2014/15 Vol% Al₂O₃p and AA2009/20 Vol% SiCw

The influence of heat treatment on the corrosion behavior of two aluminium matrix composites (AA2014/15 vol% Al₂O₃p - composite A and AA2009/20 vol% SiCw - composite B) was analyzed in 3.5% sodium chloride solution. The kinetic of the corrosion process was studied based on the gravimetric measurements. The corrosion damage and pit shape were analyzed by Image Analyzer. The corrosion damage in both composites was caused by the pitting attack on the surface. Pit shape of the composite A is different to the composite B. The corrosion rate of composite A is higher than composite B because the voids or gap between reinforcement particles and matrix are larger than in the composite B. The main attack of nucleation sites was at the interface region of the matrix and the reinforcement.

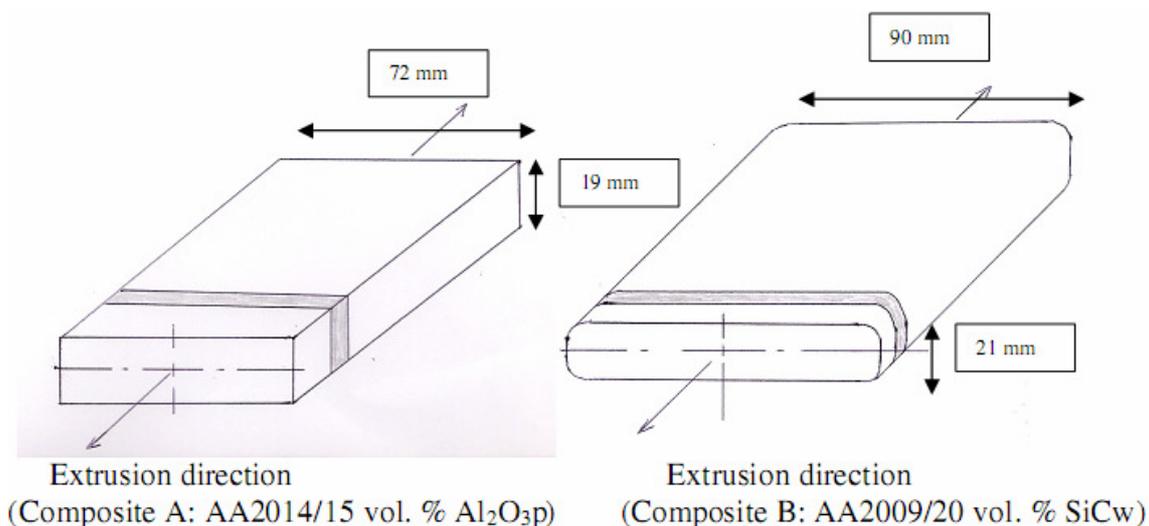
Figure 1. Schematic diagram of as-received bar of the composites from the suppliers.

Composite A was supplied by Duralcan Inc., San Diego, California, USA, and produced by casting method followed by hot extrusion process to form rectangular bar with 77 mm wide and 19 mm thickness (Fig. 1). Composite B was supplied by Advanced Composite Materials Corporation (ACMC), USA. Composite B was fabricated by powder metallurgy method followed by hot extrusion process to form a rectangular fillet bar with 90 mm wide and 21 mm thickness (Fig. 1).

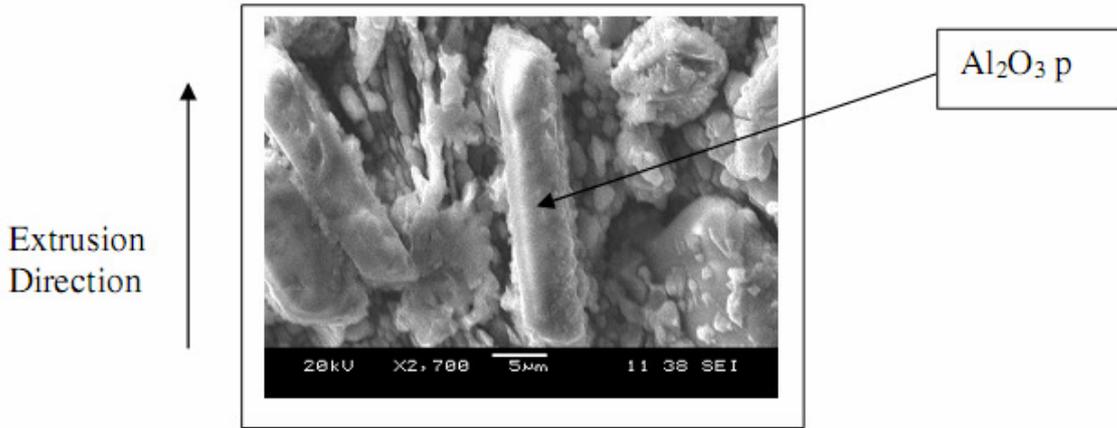
Figure 2. SEM micrograph of composite A: A2014/15%Al₂O_{3p}, parallel to the extrusion direction.

Fig. 2 shows the microstructure of composite A: AA2014/15%Al₂O₃p, parallel to the extrusion direction. Etching with an acid solution (HCl/HNO₃=1:1) reveals the grain boundaries in the matrix. The particles are moderately aligned to the extrusion direction and homogeneously distributed. Fig. 3 shows the microstructure of composite B: AA2009/20%SiCw parallel to the extrusion direction. Etching with an acid solution (HCl/HNO₃=1:1) reveals the whiskers in the matrix. The whiskers are moderately aligned to the extrusion direction and homogeneously distributed.

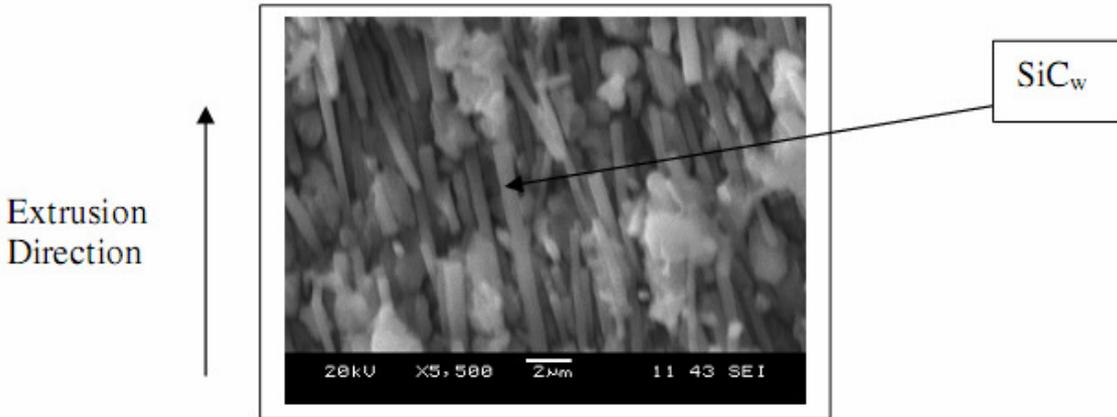
Figure 3. SEM micrograph of composite B: Al2009/20%SiCw parallel to the extrusion direction.

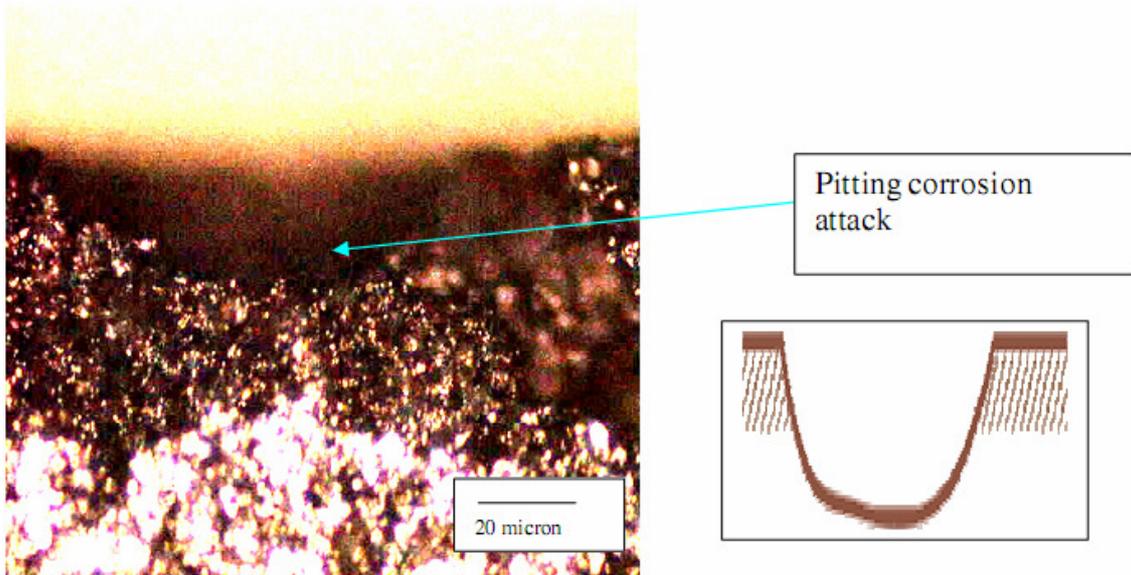
Figure 4(a). Pitting corrosion attack in the matrix through the interface $\text{Al}_2\text{O}_3\text{p}$ /matrix in composite A (AA2014/ $\text{Al}_2\text{O}_3\text{p}$ /15% (T6) MMC) in shallow wide pit shape.

Figs. 4 to 5 show the pitting corrosion attack after 28 days immersion in 3.5% NaCl for both composites. The pitting corrosion attacks the matrix through the interface reinforcement/matrix in different pit shape. Figs. 4(a) and 4(b) indicate pitting corrosion attacks after 28 days immersion in the composite A. The pitting corrosion attacks the matrix through the interface $\text{Al}_2\text{O}_3\text{p}$ /matrix indicating shallow wide pit shape and vertical grain attack pit shape. Figs. 5(a) and 5(b) indicate pitting corrosion attacks after 28 days immersion in the composite B through the interface SiCw/matrix and indicating shallow deep pit shape. It was

observed that the pitting processes were rapid with shallow wide pit shape and vertical grain attack pit shape compare to shallow deep pit shape.

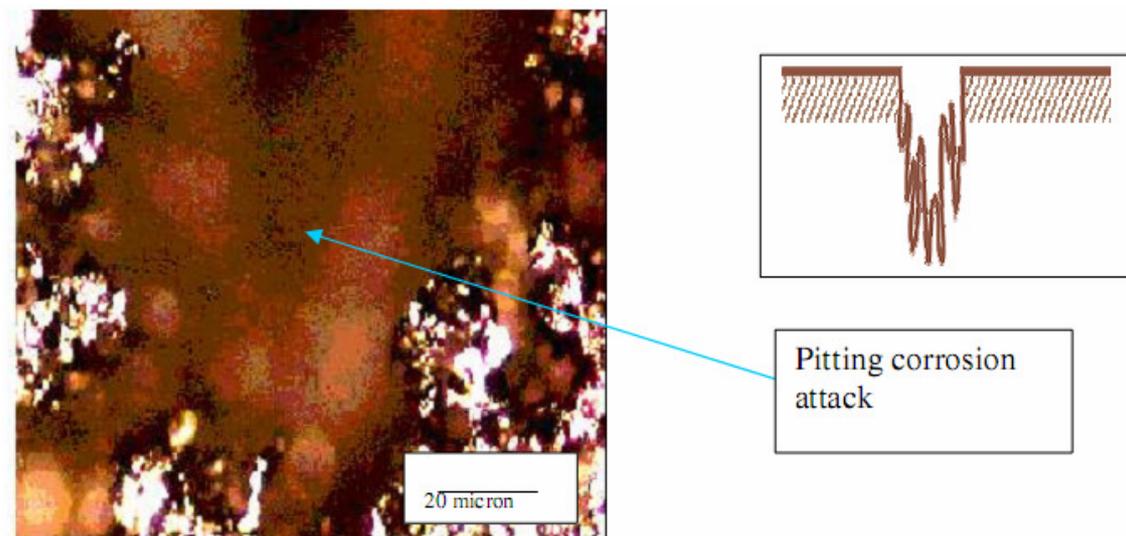
Figure 4 (b). Pitting corrosion attack in the matrix through the interface $\text{Al}_2\text{O}_3\text{p}$ /matrix in composite A (AA2014/ $\text{Al}_2\text{O}_3\text{p}$ /15% (T6) MMC) in vertical grain attack pit shape.

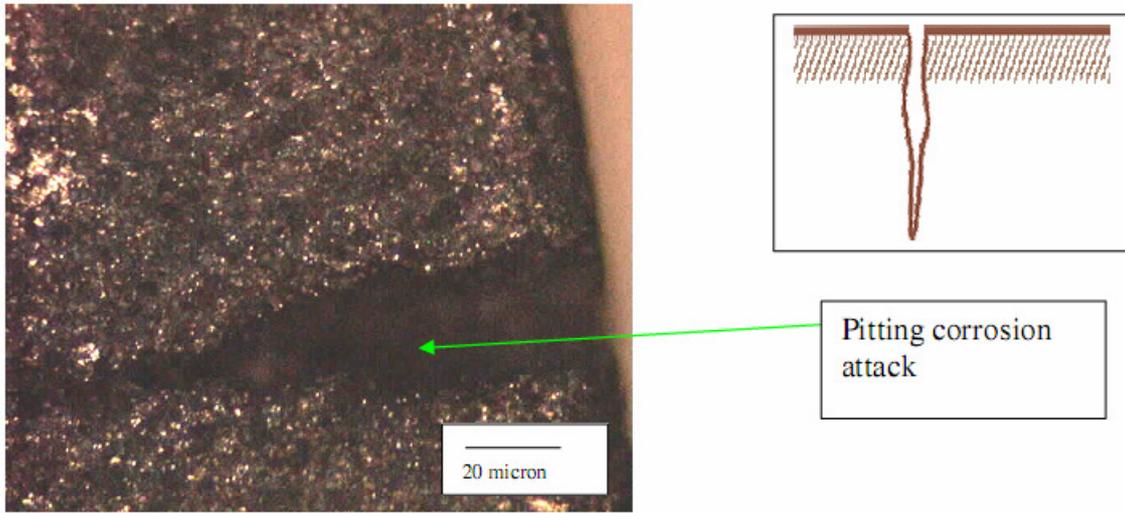
Figure 5(a). Pitting corrosion attack in the matrix through the interface SiCw/matrix in composite B (AA2009/SiCw /20% (T6) MMC) in shallow deep pit shape.

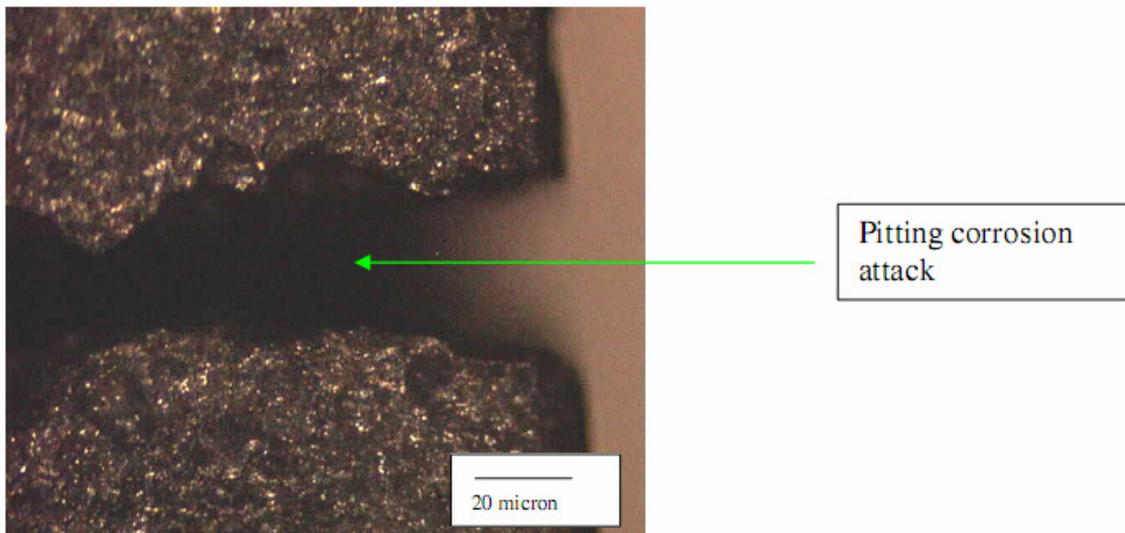
Figure 5(b). Pitting corrosion attack in the matrix through the interface SiC/matrix in composite B (AA2009/SiC w /20% (T6) MMC) in shallow deep pit shape.

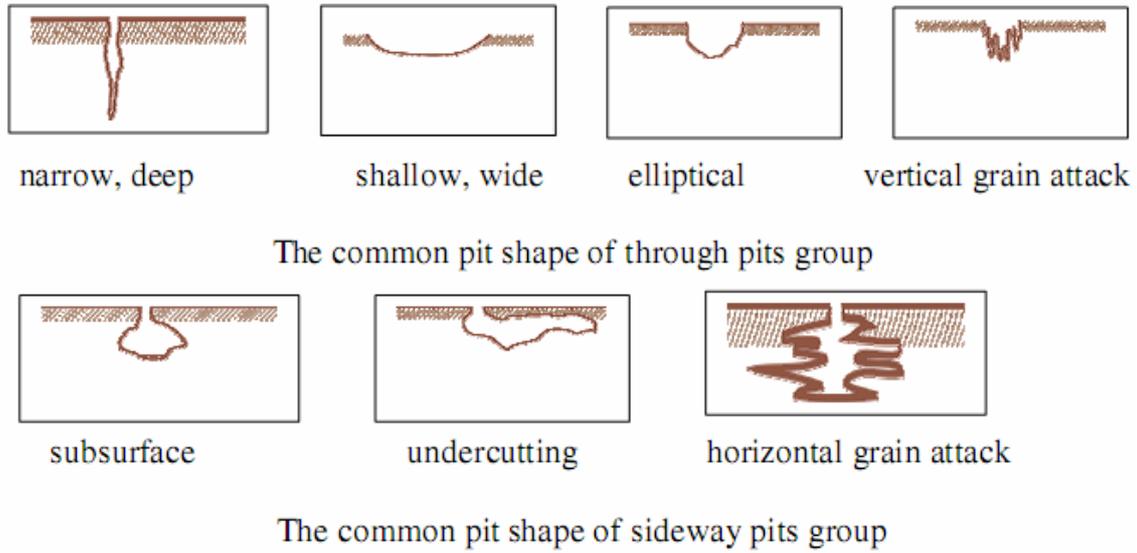
Figure 6. Common pit shape of through pits group and sideway pits group [17].

virtually unaffected. The following are common pits shape divided in two groups, as shown in Fig. 6.

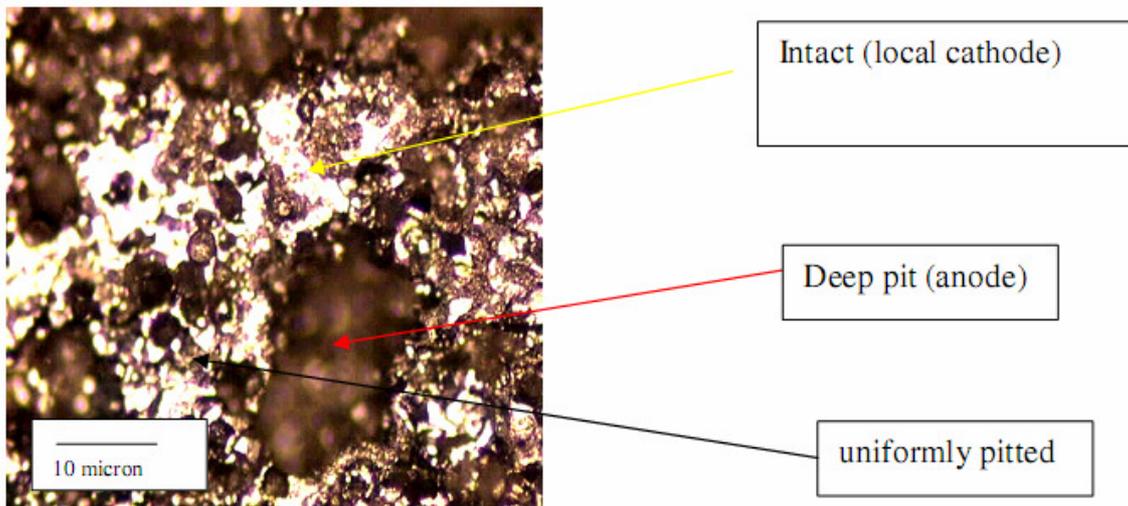
Figure 7. Holes due to an intensive matrix corrosion in composite A (AA2014/ Al_2O_3p /15%p (T6) MMC).

Figs. 7 and 8 show the holes due to the intensive matrix corrosion in the composites A and B. This example of a pitted surface was produced by exposing a sample to a 3.5% NaCl during 28 days. Most of the surface is uniformly pitted (black arrow), as both composites would do in similar conditions. It is seen the formation of deeper pits (red arrow) that are surrounded by un-attacked regions (yellow arrow). However, the main reason for their poor corrosion resistance is attributed to the crevices at the Al_2O_3/Al interface and $SiCw/Al$ interface as preferential site of attack, as shown in Figs. 7 and 8.

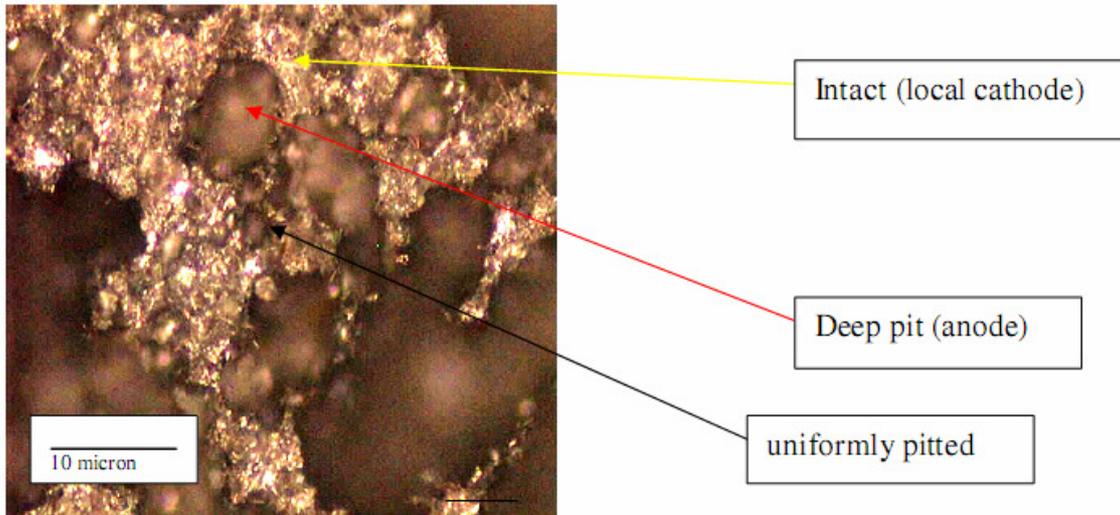
Figure 8. Holes due to an intensive matrix corrosion in composite B (AA2009/SiC/20%w (T6) MMC).
