**Study on the Potential of Repair Fire-Damaged  
Reinforced Concrete Beams Using Ultra High  
Performance Concrete with Curing at Ambient  
Temperature**

A thesis submitted in fulfillment of the requirements for the degree of  
Master of Science (Civil Engineering)

**School of Environmental Engineering  
UNIVERSITI MALAYSIA PERLIS**

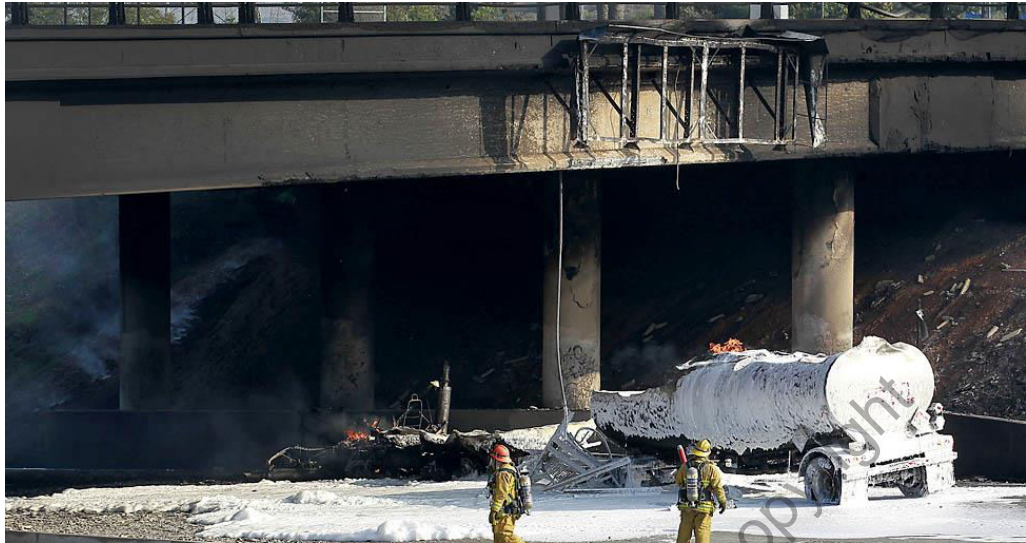
Figure 2.1: Tanker truck exploded beneath the 60 Freeway in California which caused damage to overhead bridge (LA Times, 2011).

Fire accident can occur to building structure and even to public infrastructure. Example of building structure damaged due to fire accident is St. Elizabeth Hospital in Holland (De Lange, 1980). The fire accident occurred in 1950 and used epoxy injection and shotcrete in the repair work. Example of fire accident on infrastructure is the explosion of tanker truck under 60 Freeway in California on 14<sup>th</sup> December 2011 (Figure 2.1). The fire caused guardrail to melt and charred concrete structures. On 27<sup>th</sup> April 2007, a gasoline truck overturned and erupted into flames caused California Highway to collapse (Figure 2.2). Another example of infrastructure fire accident is Dean's Brook Viaduct. The viaduct located in London was fire-damaged due to fire in scrap yard at south span of the bridge (Wheatley et al., 2014).

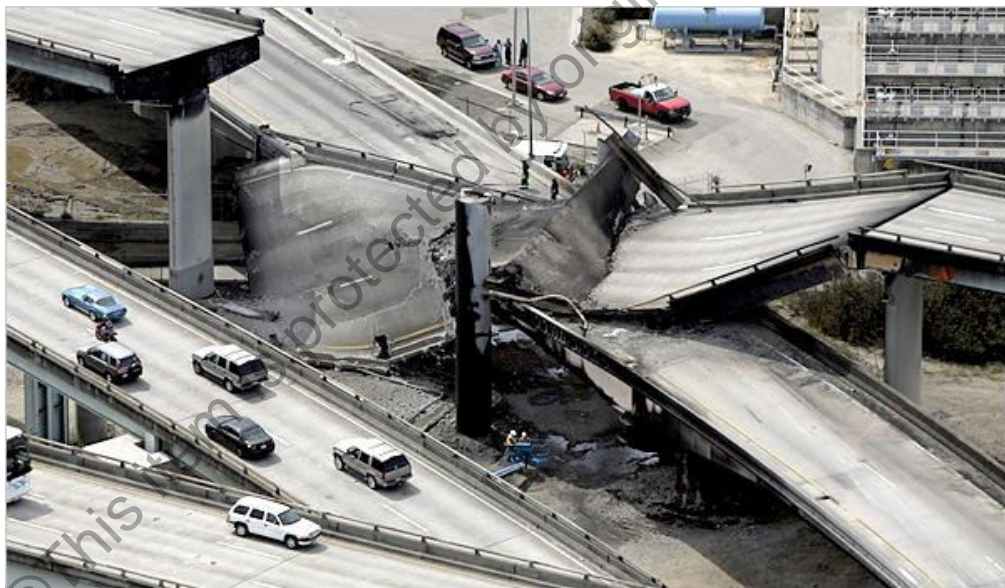
Figure 2.2: Collapsed freeway overpass near San Francisco, California (New York Times, 2007)
