Another Glimpse of Engineering Geology – A Pictorial Presentation of Limestone Bedrock Pinnacles

By: Assoc. Prof. Tan Boon Kong

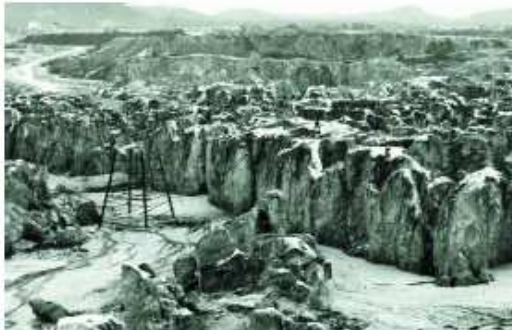
Figure 1: Limestone pinnacles exposed by alluvial mining

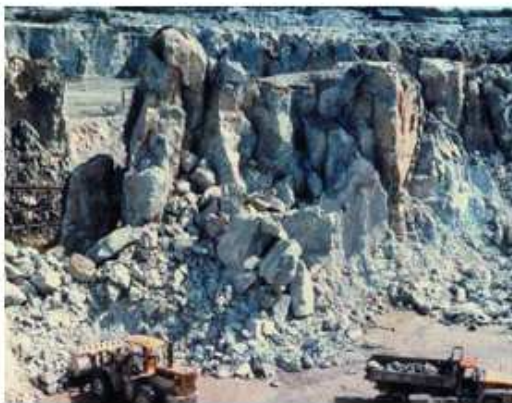
Figure 2: Limestone pinnacles during quarrying activities

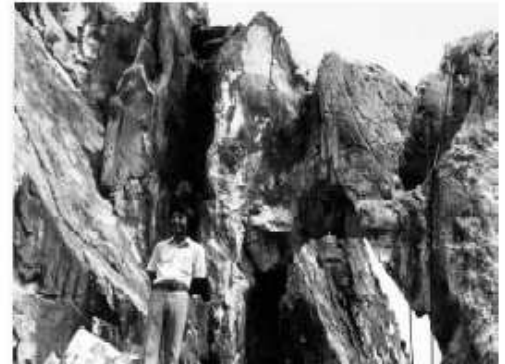
Figure 3: Limestone bedrock arch showing large solution cavity or channel

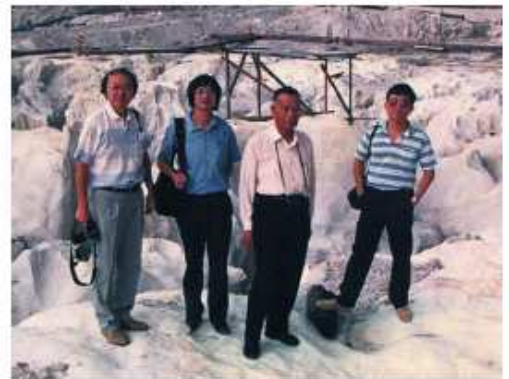
Figure 4: Close-up of top of limestone pinnacles. Left to right: Dr Chan S.F., Chan Y.C., the late Prof. Chin F.K., Tan B.K. (photo courtesy of Chan Y.C., GEO, Hongkong)

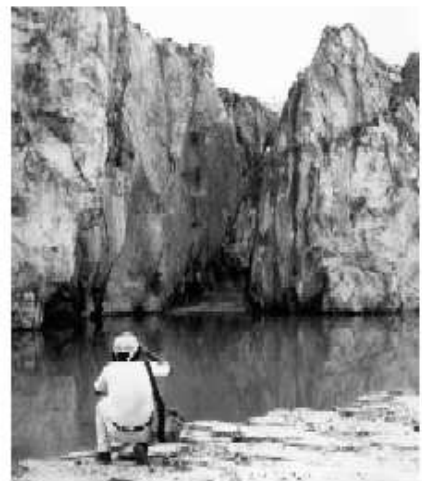
Figure 5: Close-up of limestone pinnacles viewed from the side
