Fire Safety Permits

by Ir. Loo Chee Kin

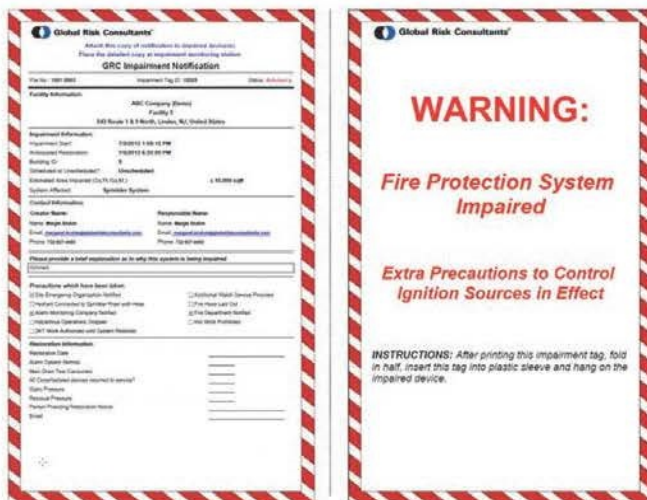
Figure 3: Sample of a fire protection impairment permit. On the left is the front with the impairment data and right is the back with the warning details.

It's a recipe for a bigger disaster when the active fire protection is out of service and hot work is being carried out. A fire protection impairment permit, or red tag permit as some insurance companies call it, is a system to monitor such impairment. Figure 3 shows a completed sample. Fire protection could be impaired due to:

The fire protection impairment permit should be used to indicate that a system has been removed from service. The extent and expected duration of the impairment should be indicated on the permit. The areas or buildings involved must be inspected and the increased risks determined. When a permit is issued, the insurance company, the alarm company and property owner should be notified. Even the local fire brigade must be notified if the impairment is extensive or prolonged. The fire system owner should do a risk assessment and make recommendations to the management or the property owner on how the current
